Thank you for selecting CPI for your property inspection.

Inspector : **Ruth Lindley**

**Report ID#**

**HE0919RL**

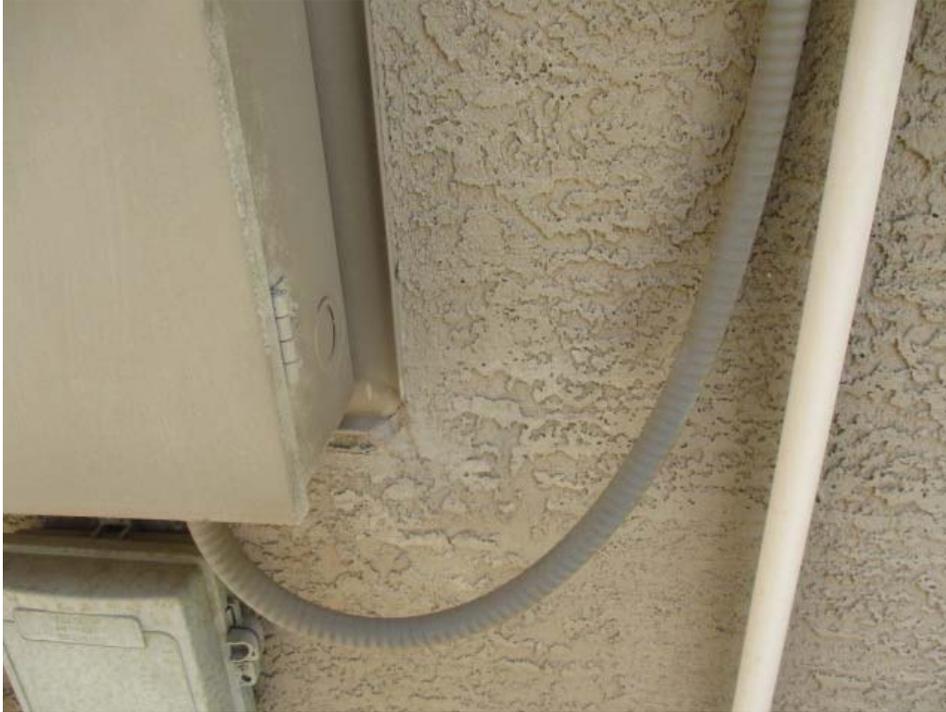
1

Recommend securing conduit to the wall at the landscape timer.

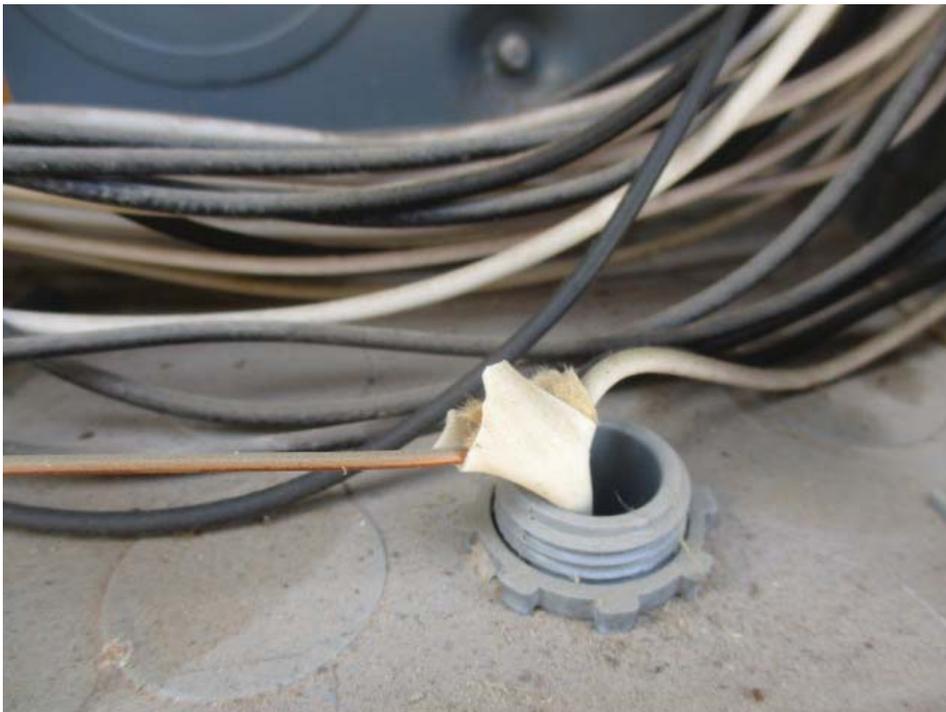
2

Romex wire has been used inside conduit at the landscape timer, recommend repairs with proper type wire.(2)

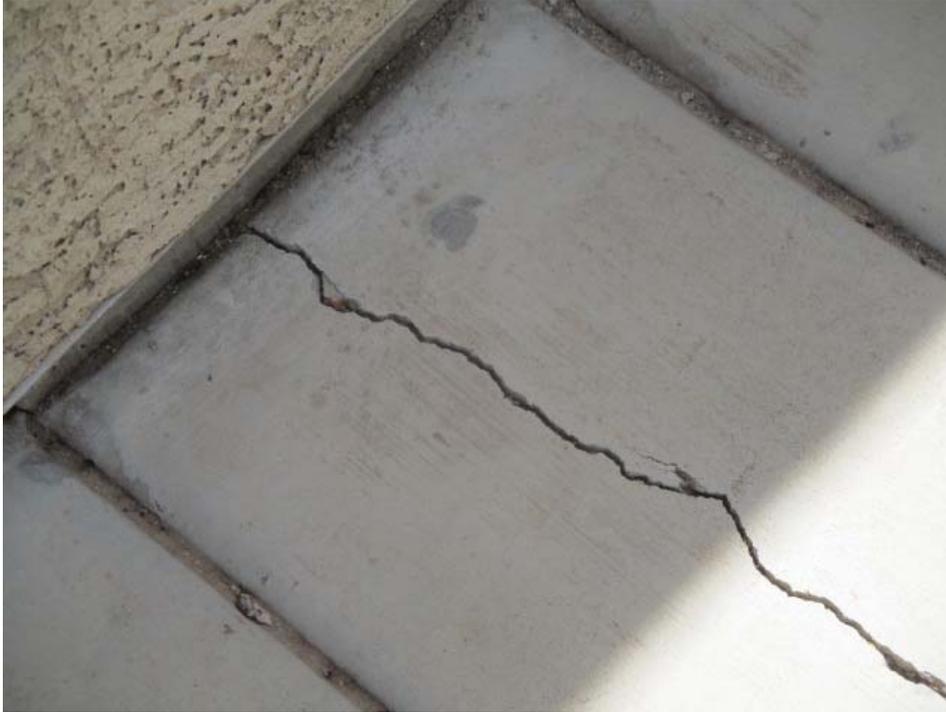
3

Sidewalk has minor cracking with some separation, recommend repairs to prevent further damage.

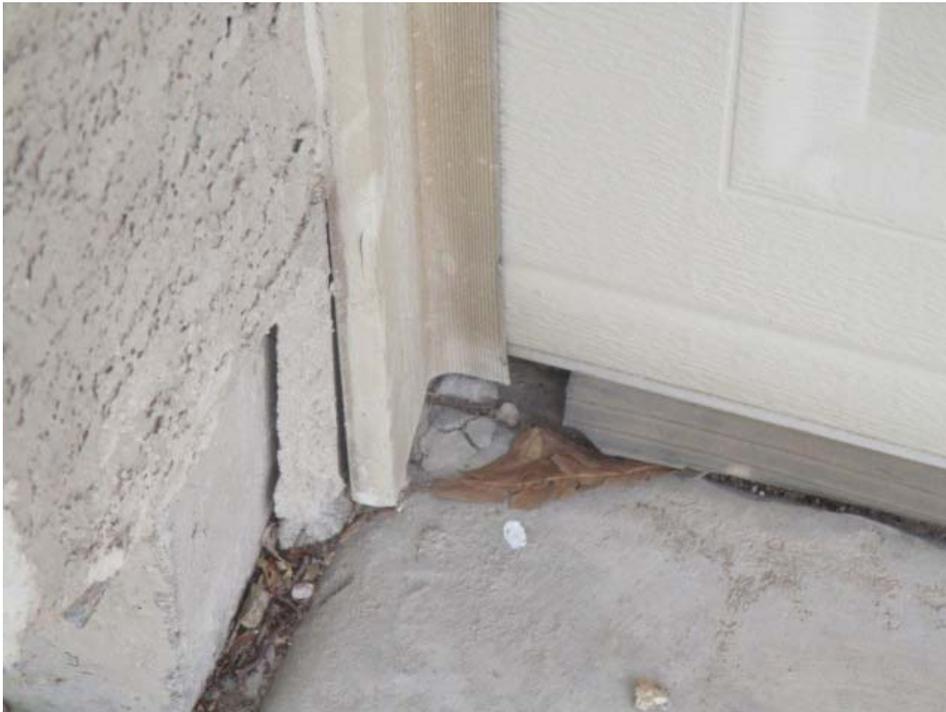
4

Separation was observed at the base of the vehicle door weather seal and trim. Recommend repairs to prevent further movement or damage.

Garage door lower seal is damaged, recommend repairs replacing.

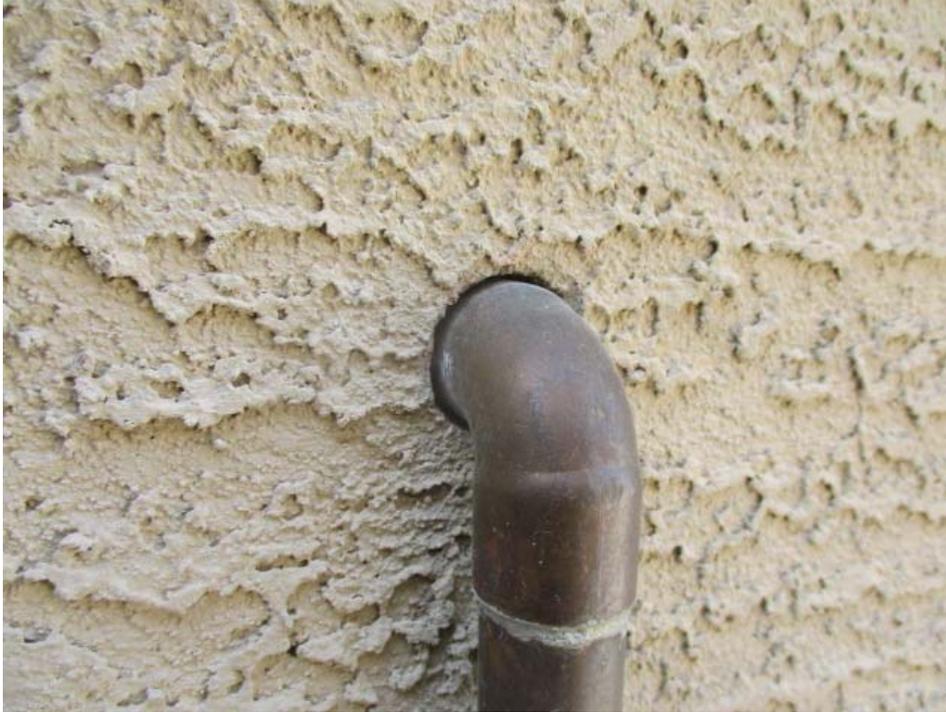
5

Recommend sealing around the copper pipe at the east side.

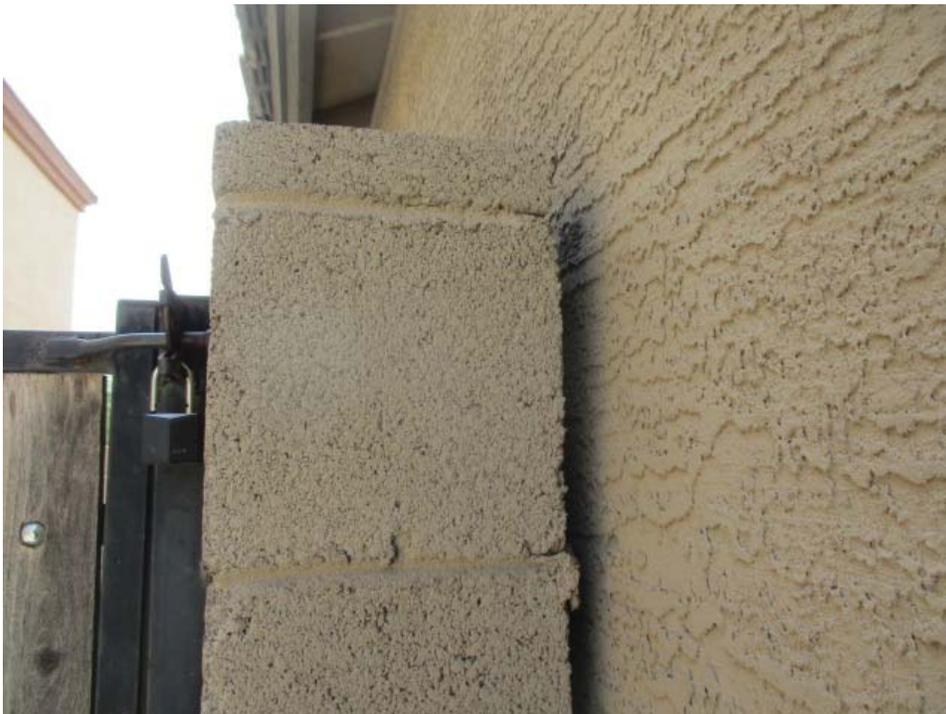
6

Pilaster for the side gate is loose and shifted from the structure, recommend securing for easier operation of the side gate.

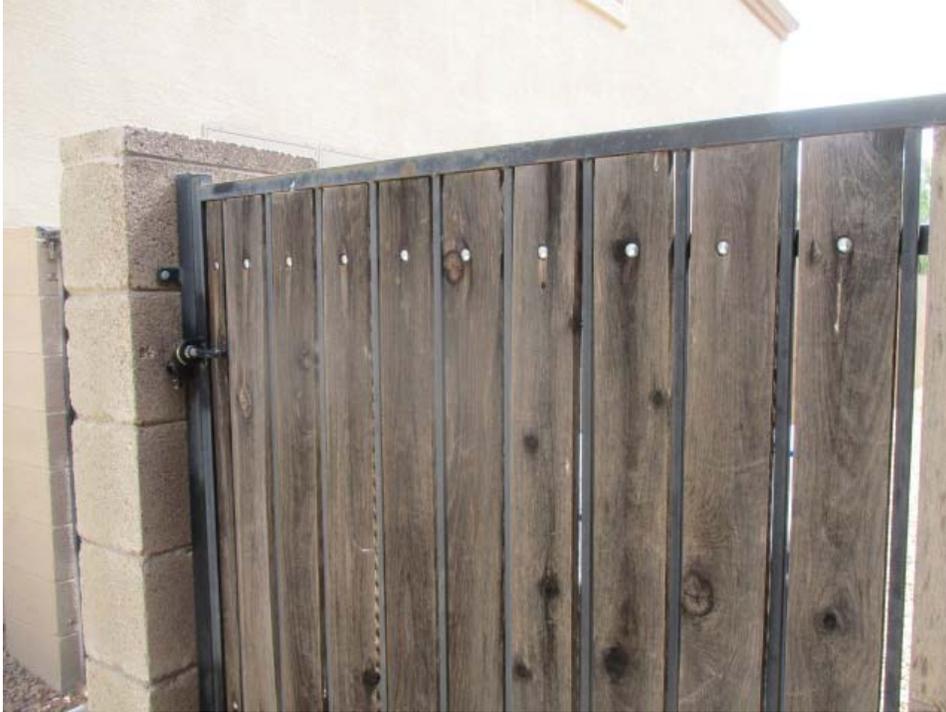
Light rust and weathering was noted on the side gate. Recommend regular maintenance and repairs to prevent damage.

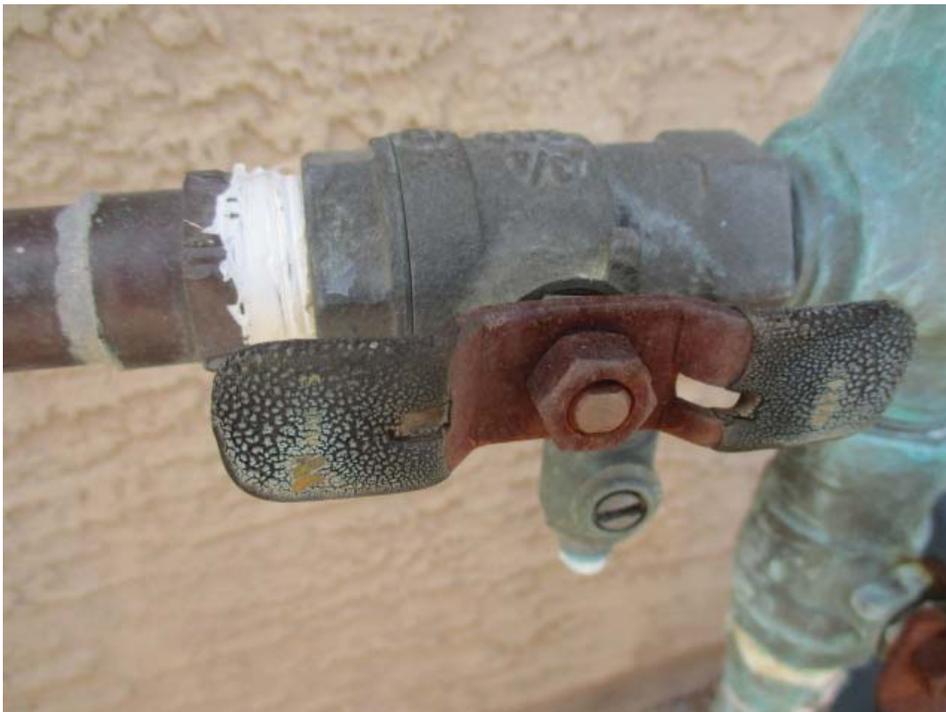
8

Valves for the sprinkler water supply are rusted and corroded, recommend maintenance for easier operation.

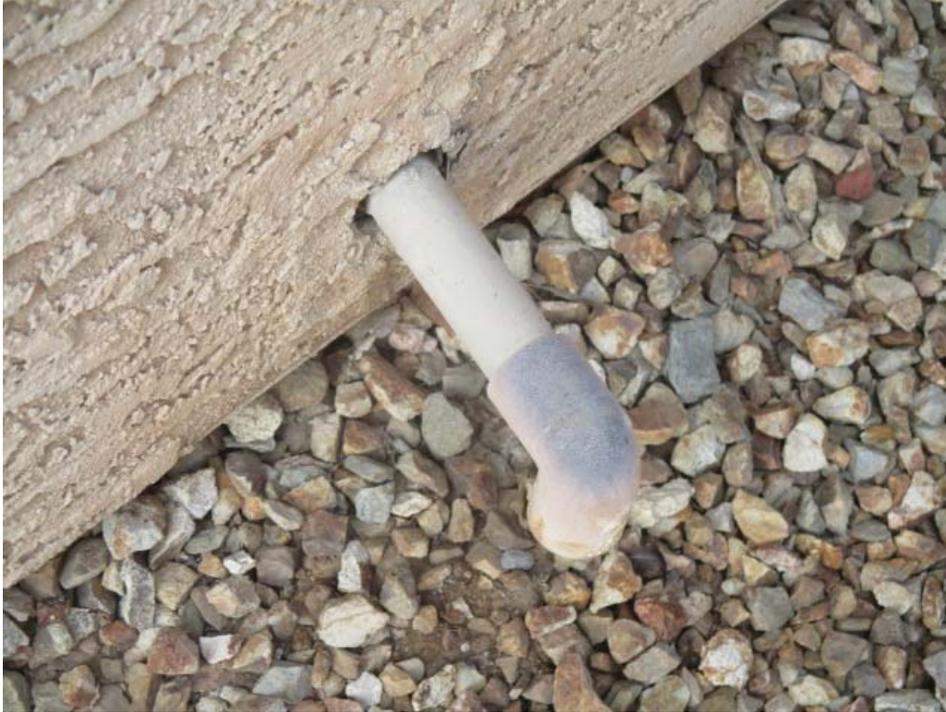
9

The primary condensation drain line extends too far beyond the wall and is subject to damage, recommend shortening.

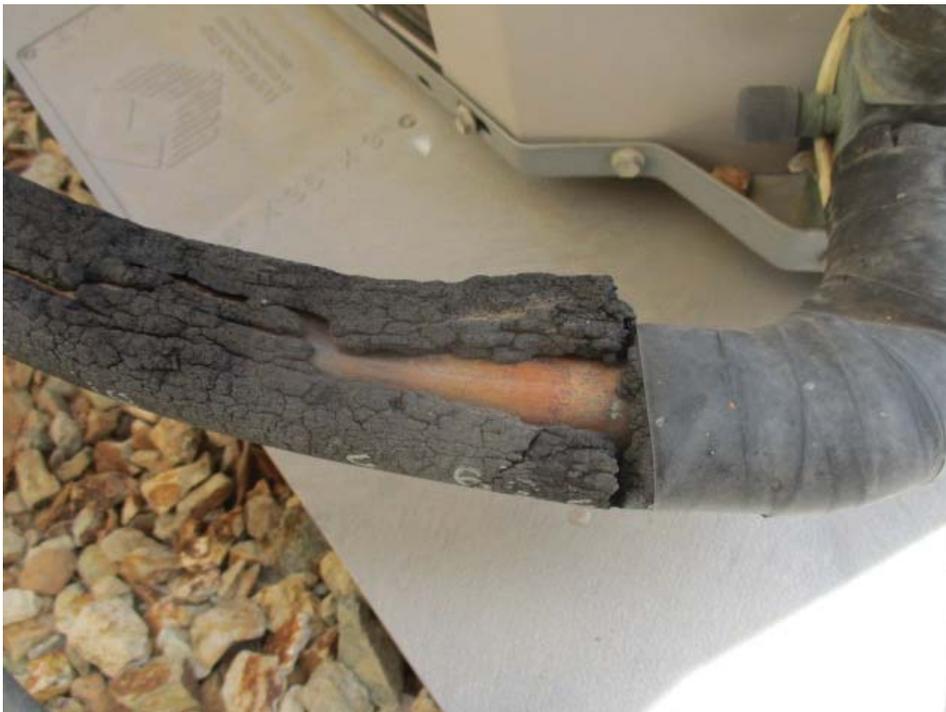
10

The insulation on the A/C exterior refrigerant line is damaged, recommend replacing.

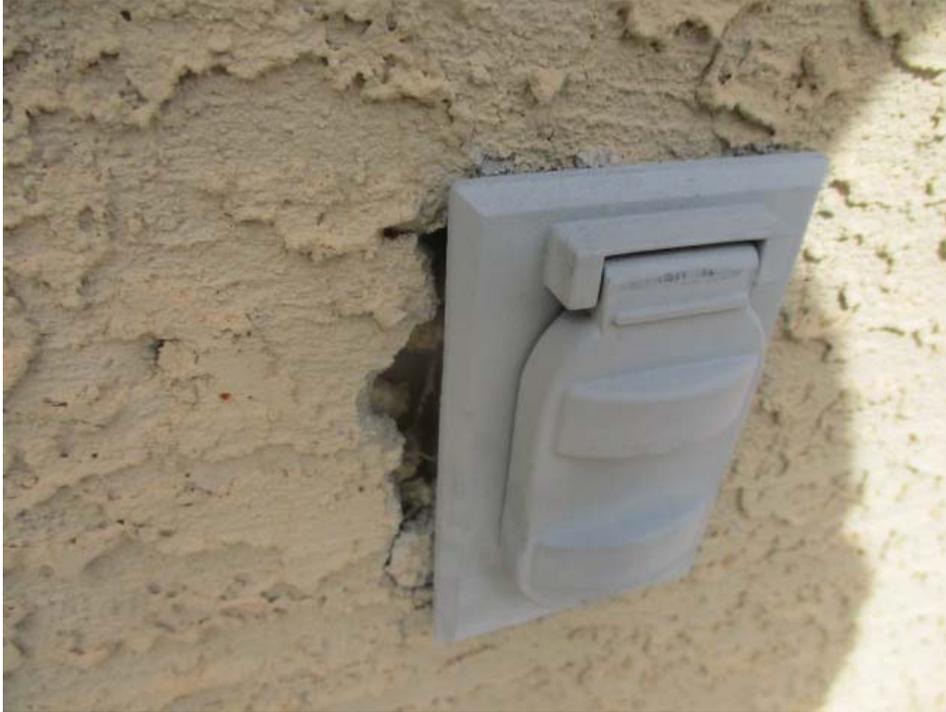
11

Exterior stucco is in need of repair in a few areas including at the south outlet.

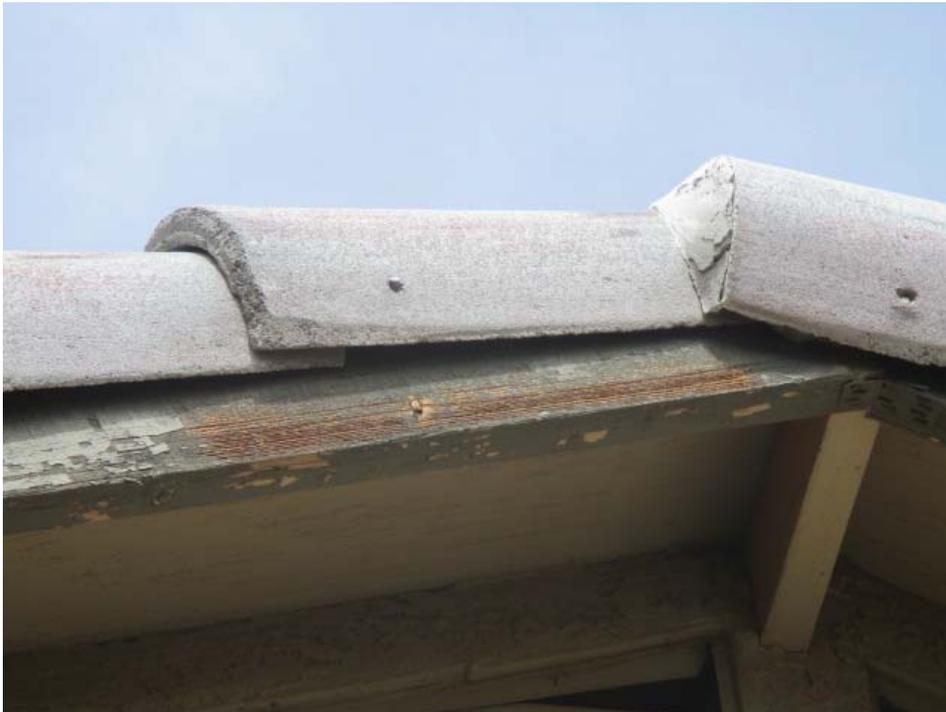
12

Exterior wood trims need sealing (caulk / paint) for weather protection.

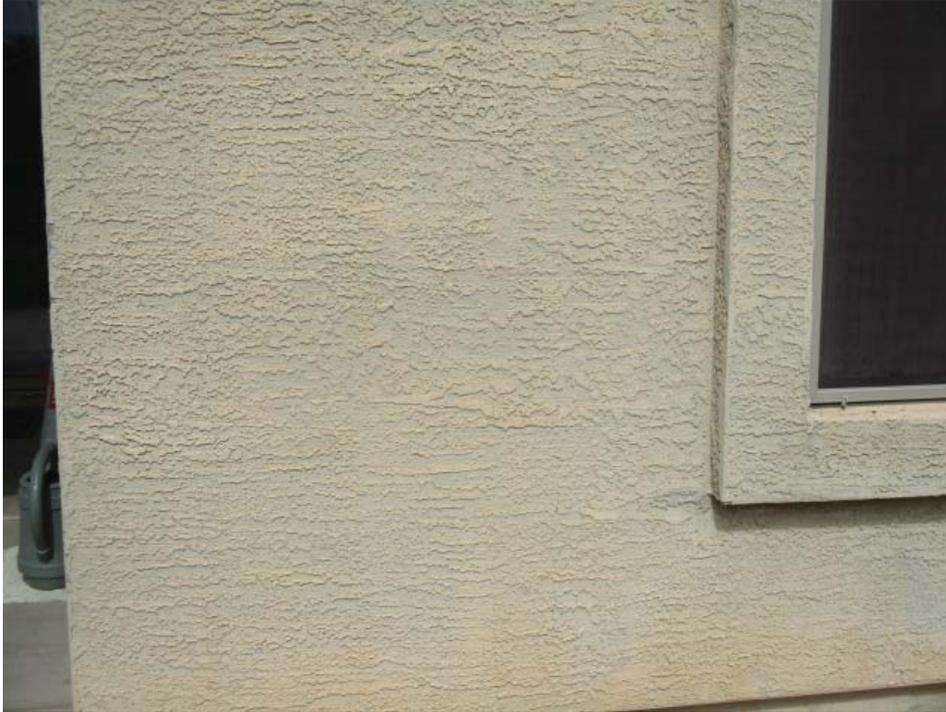
Paint at the exterior stucco is faded and cloudy, painting is recommended.

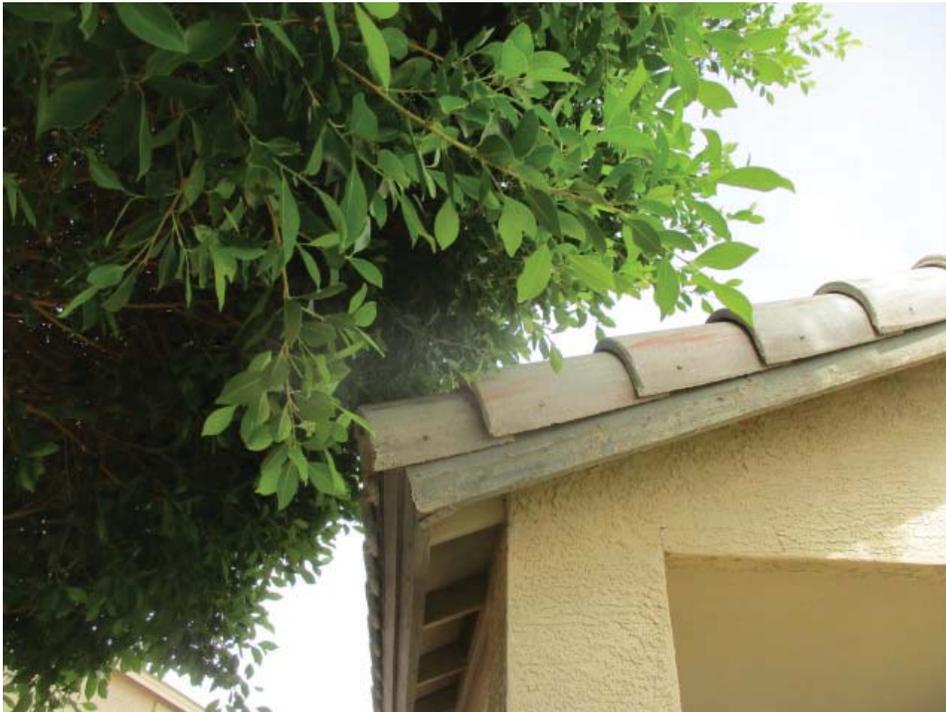
14

Recommend trimming the tree that contacts and overhangs the roof at the southwest corner.

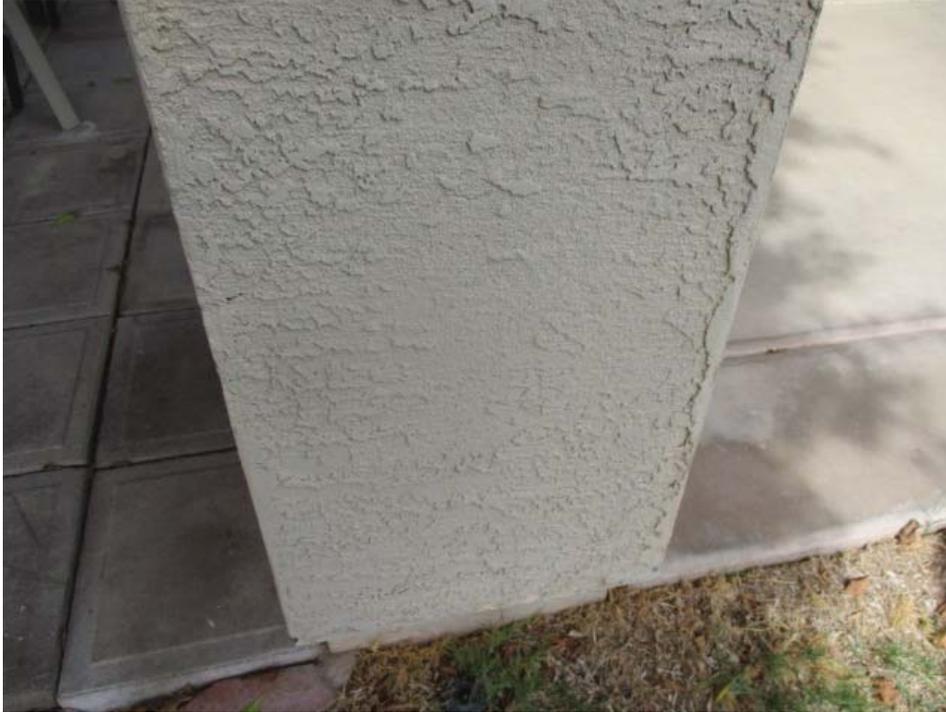
Patio post and slab appear to be moisture stained by sprinklers over spray, recommend directing sprinklers away from the patio.

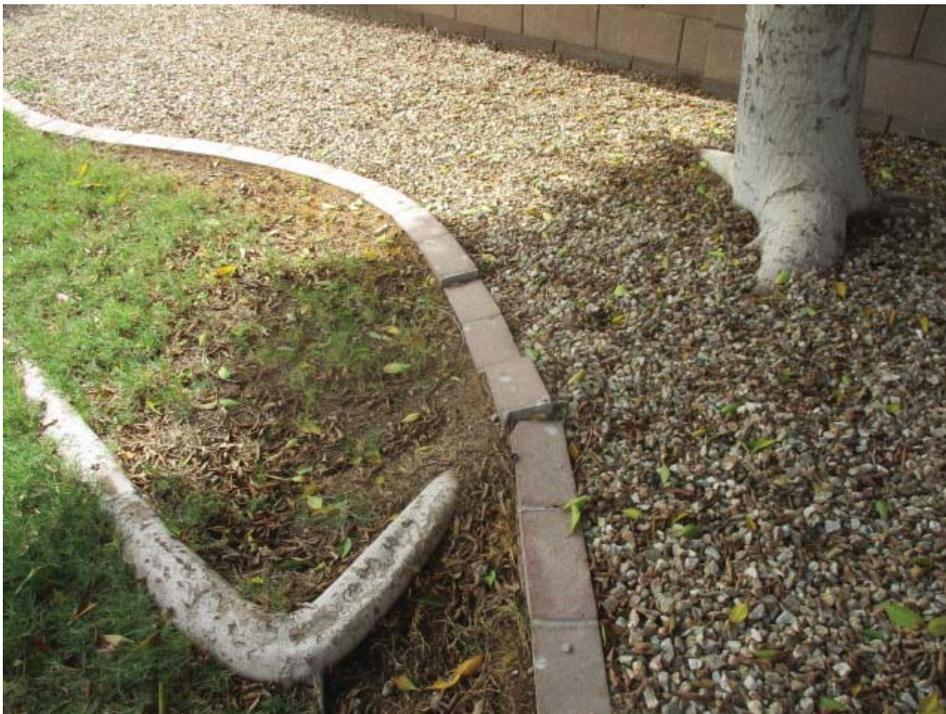
16

Brick curbing is lifted and displaced by the tree root.\*

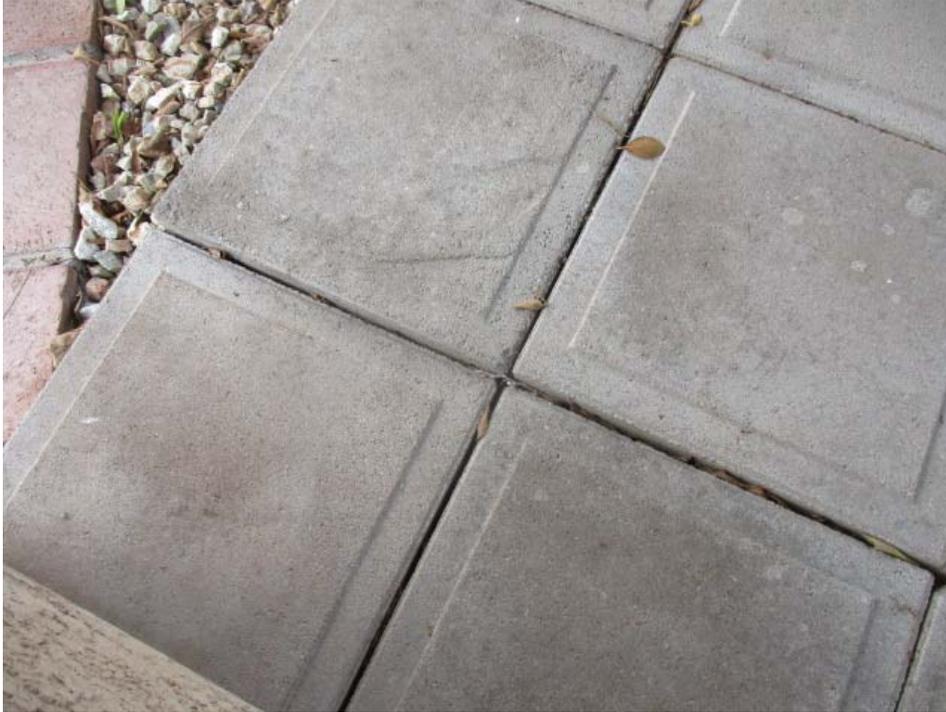
Patio pavers are shifted in a few areas creating tripping hazards, recommend repairs as needed.

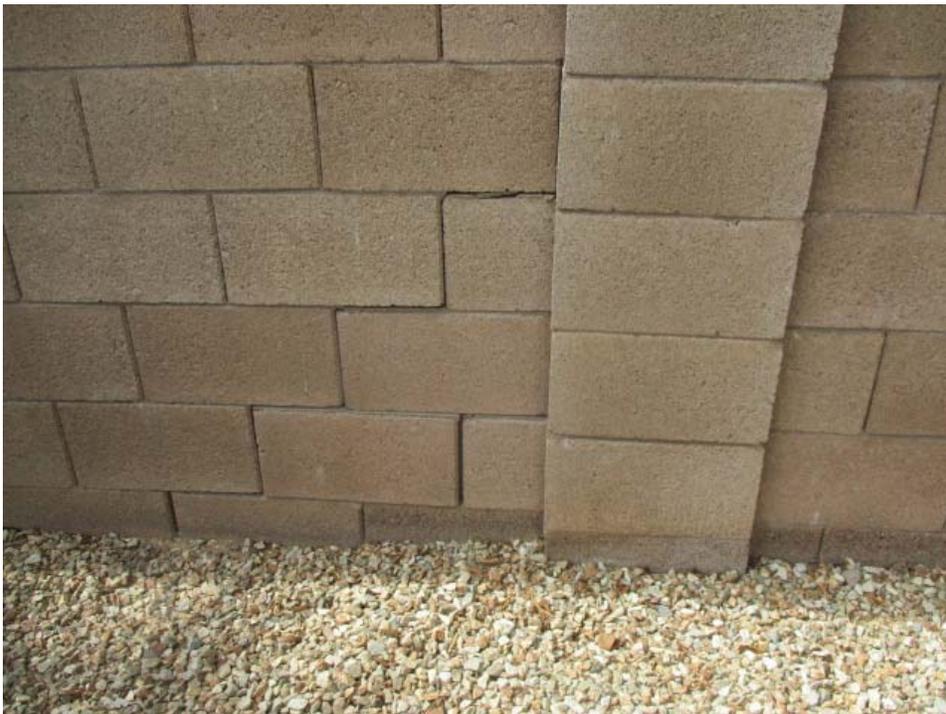
18

Block fence appears settled at the southwest side with loose blocks and cracked mortar, recommend repairs.

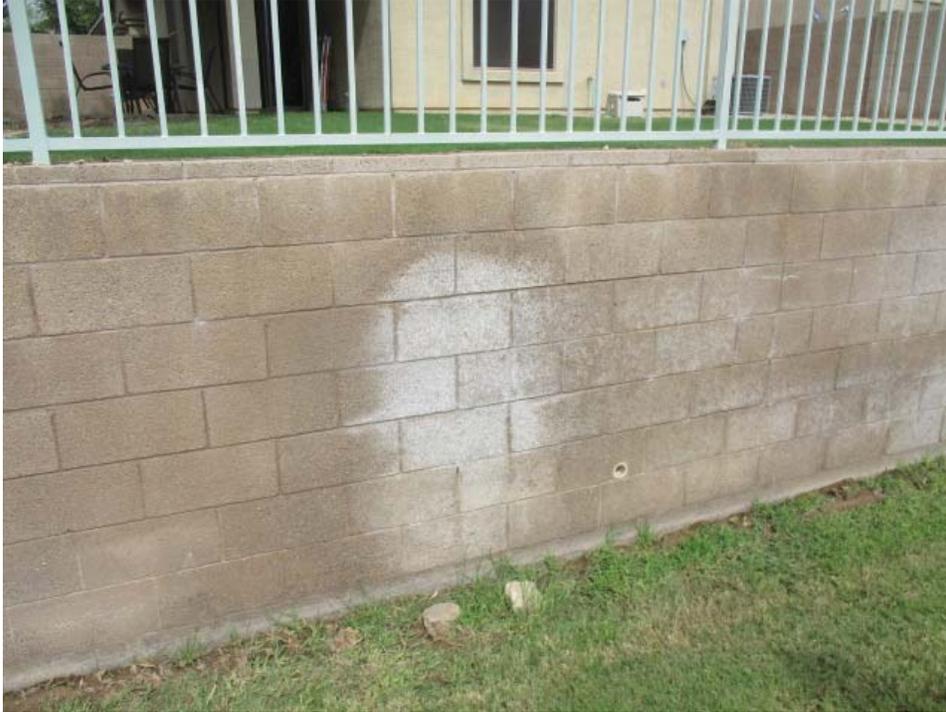
Retaining wall is moisture stained, recommend directing water away from the wall.

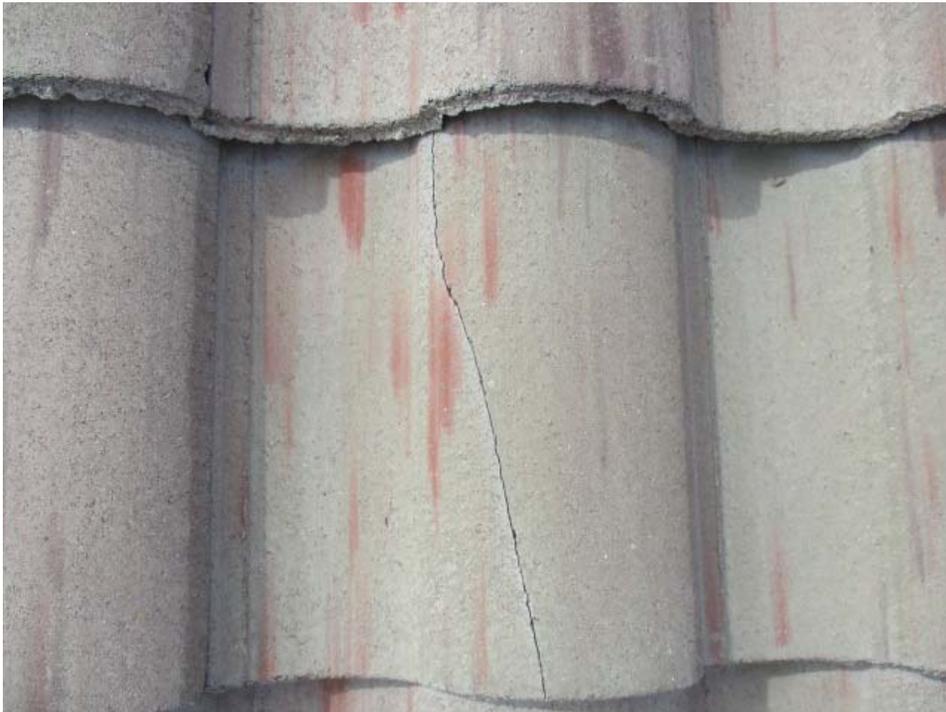
20

Main roof has 2 or more damaged tiles, recommend repairs.(2)

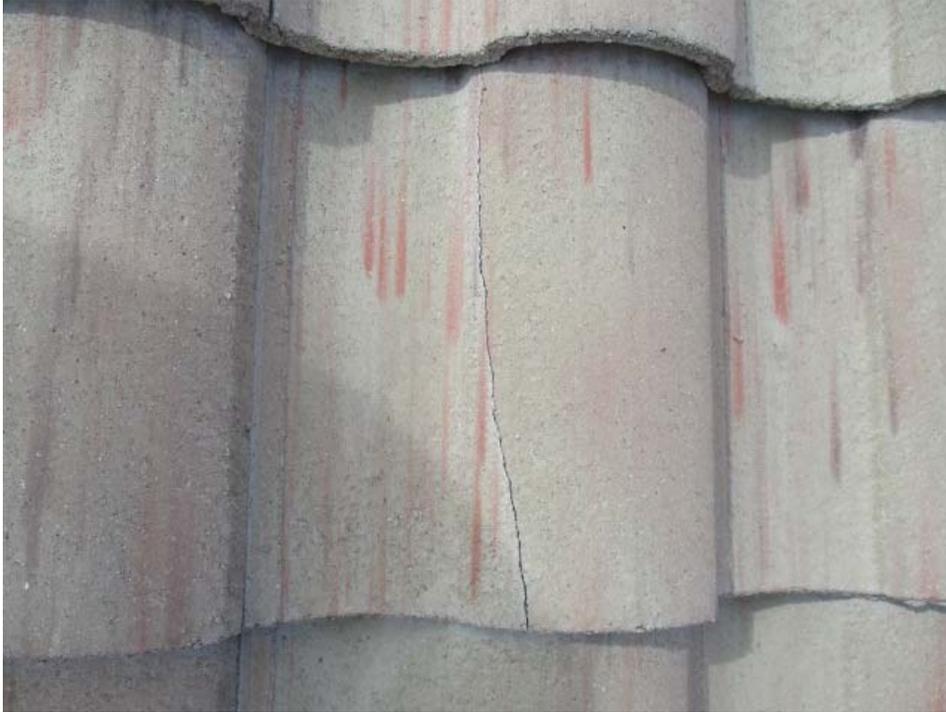
Main roof has 2 or more damaged tiles, recommend repairs.(2)

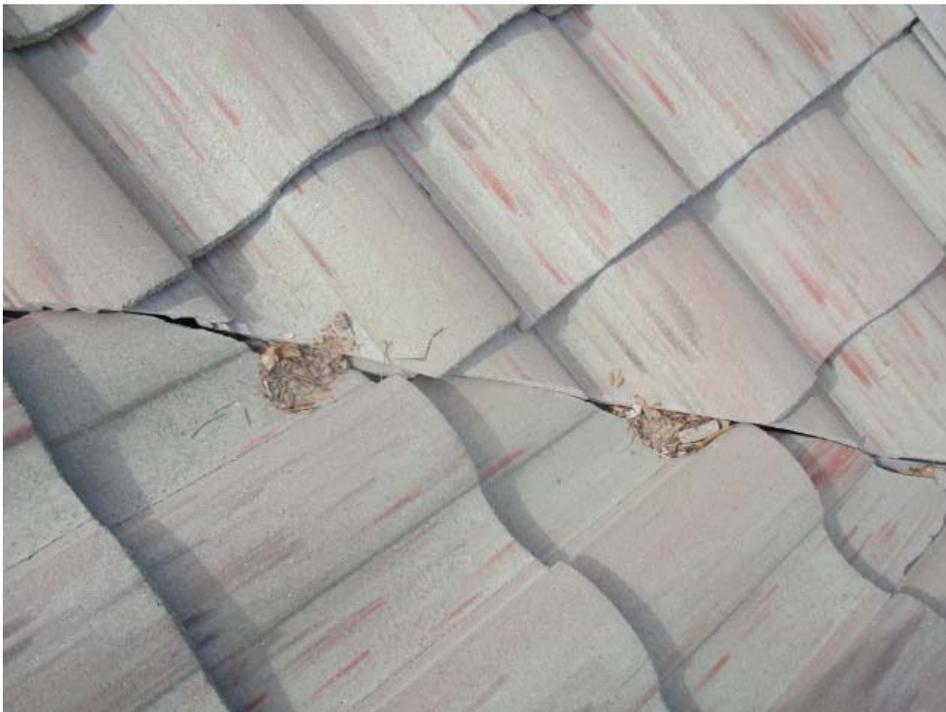
22

Roof appear to lack sufficient space between tiles in the valleys and debris is not properly shed, recommend trimming the tiles to allow proper water flow and debris shedding.

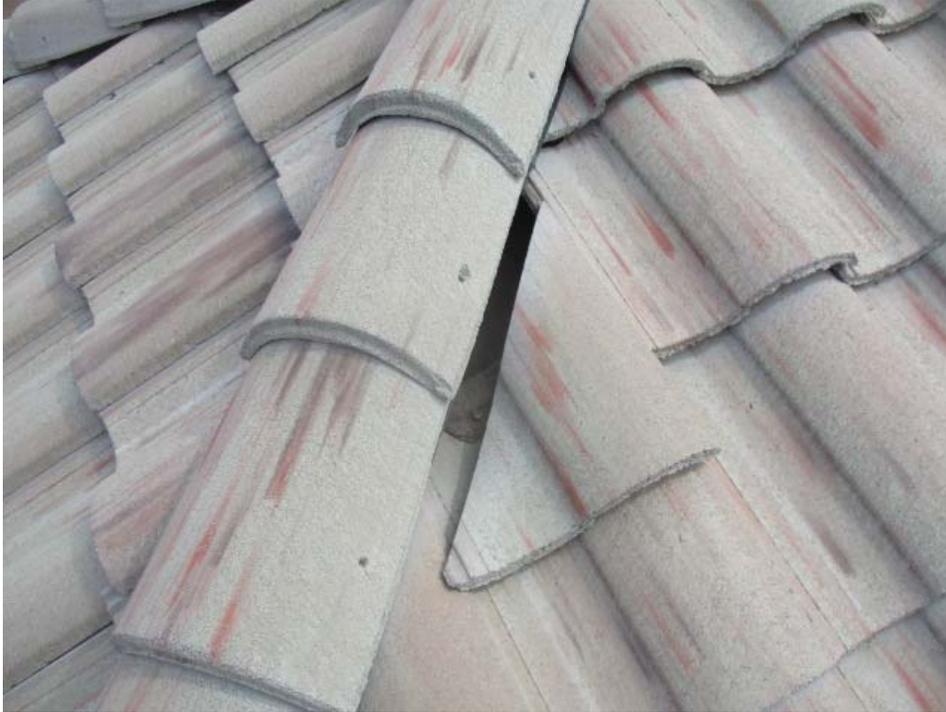
23

Main roof ha 1 or more displaced tiles, recommend repositioning and securing.(2)

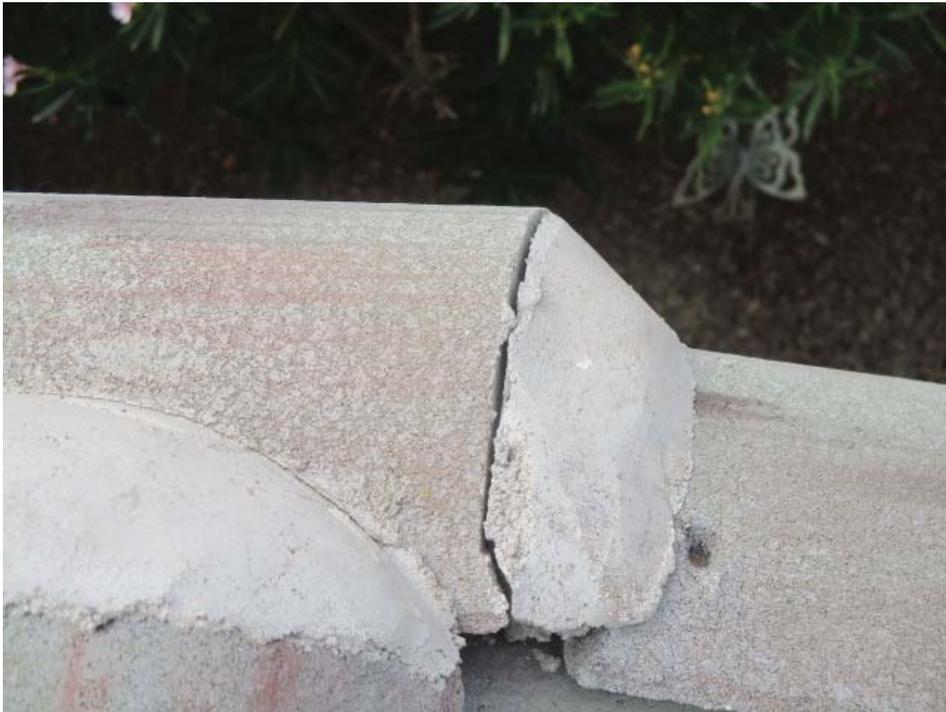
24

Mortar on the main roof is cracked and separated, recommend repairs. (2)

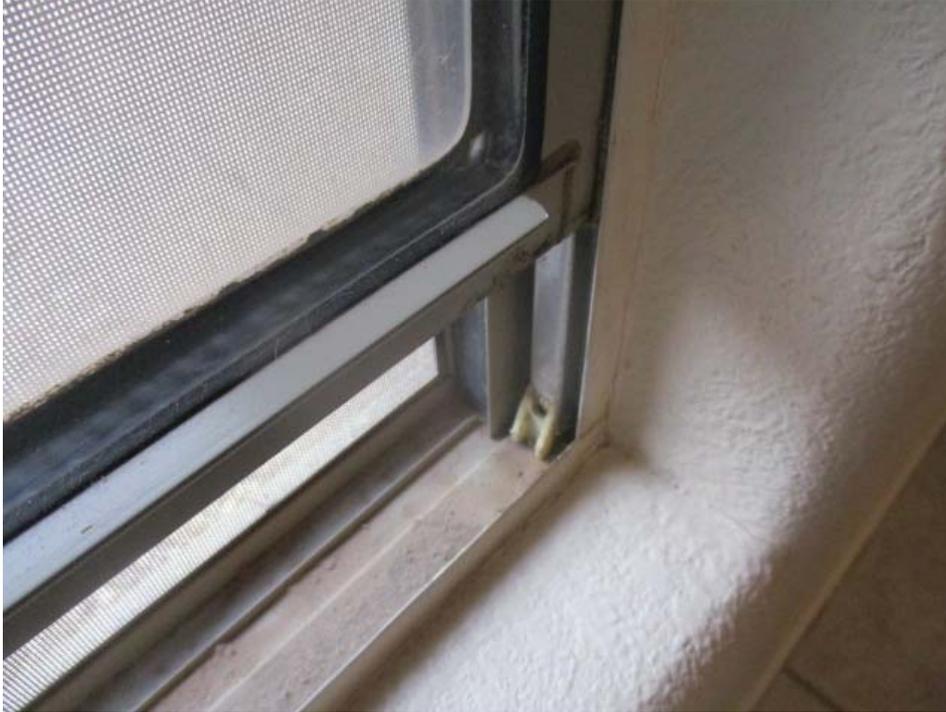
25

Living room window needs repair for proper operation.

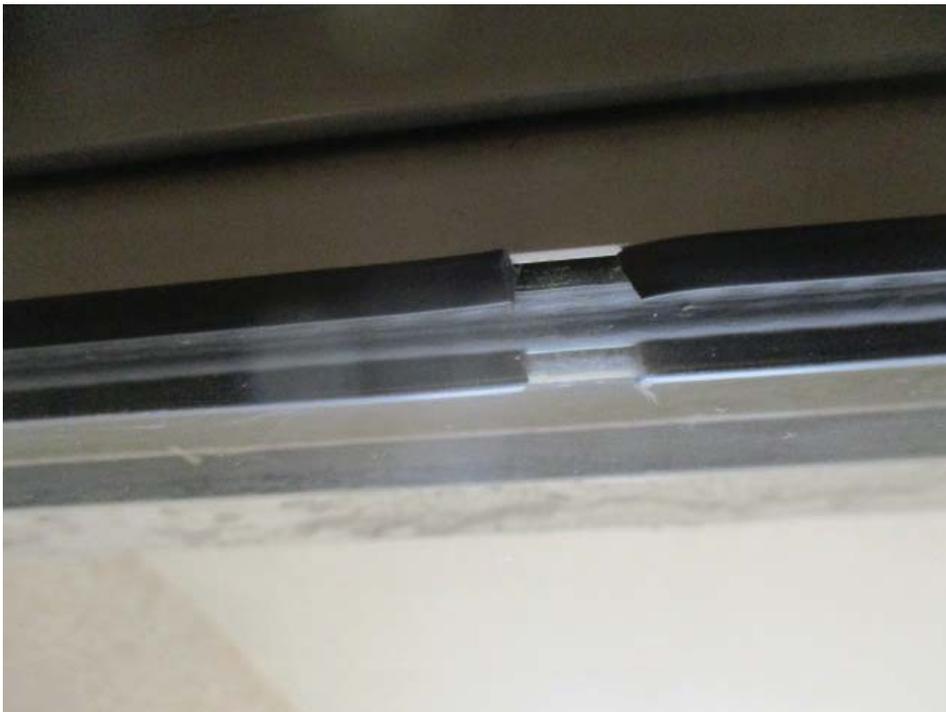
26

Seal for the sliding door is slightly damaged or displaced.

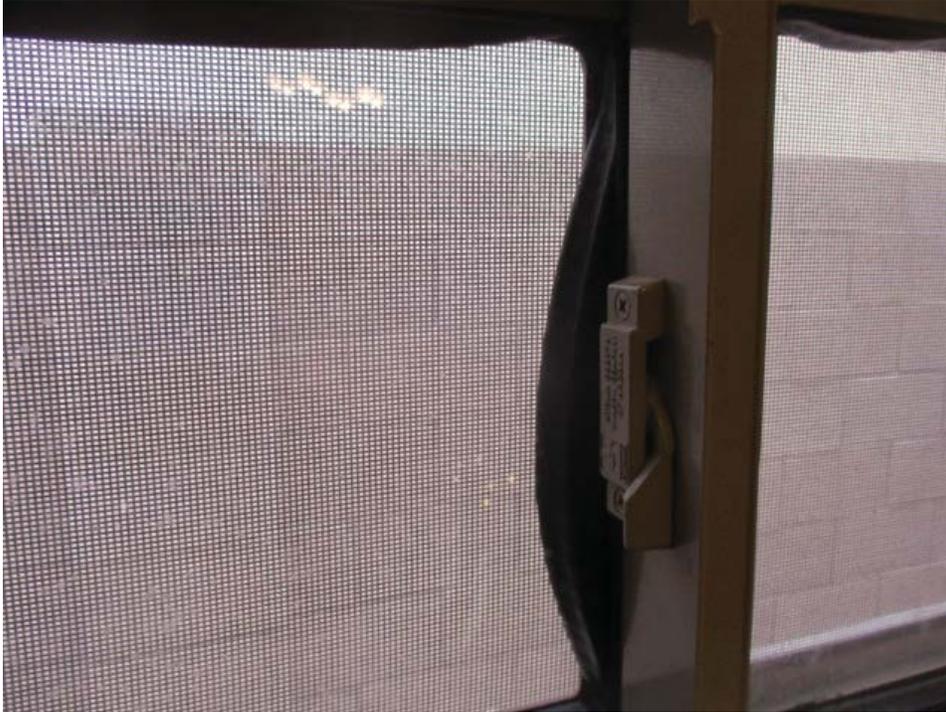
27

Window seals are damaged or displaced in various areas including the kitchen, bedroom #2 and main bath A.\*

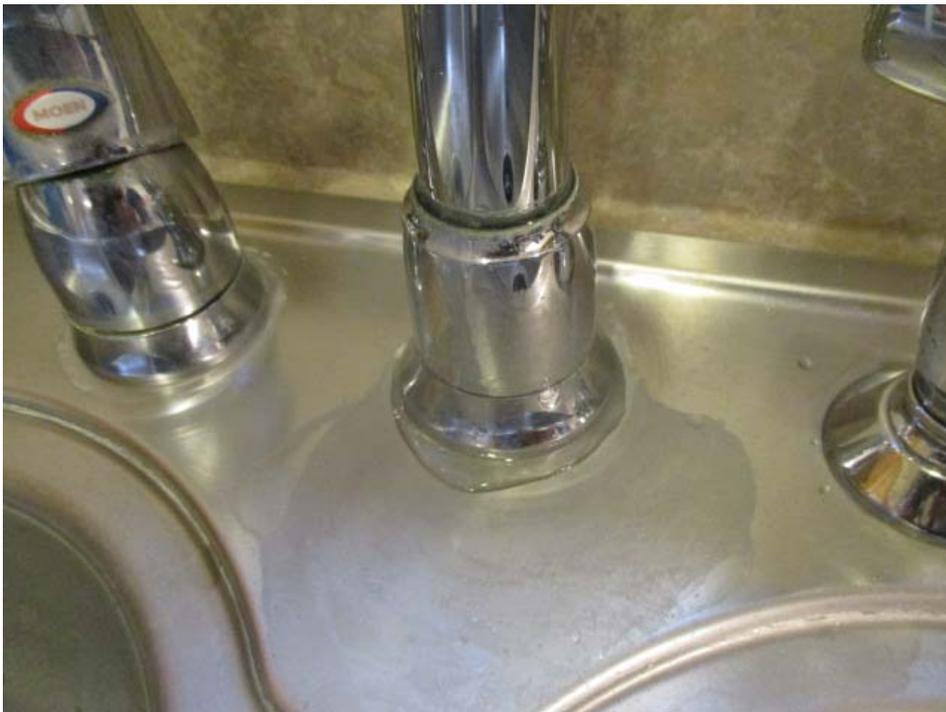
28

Kitchen faucet leaks when operated, recommend repairs / replacing.

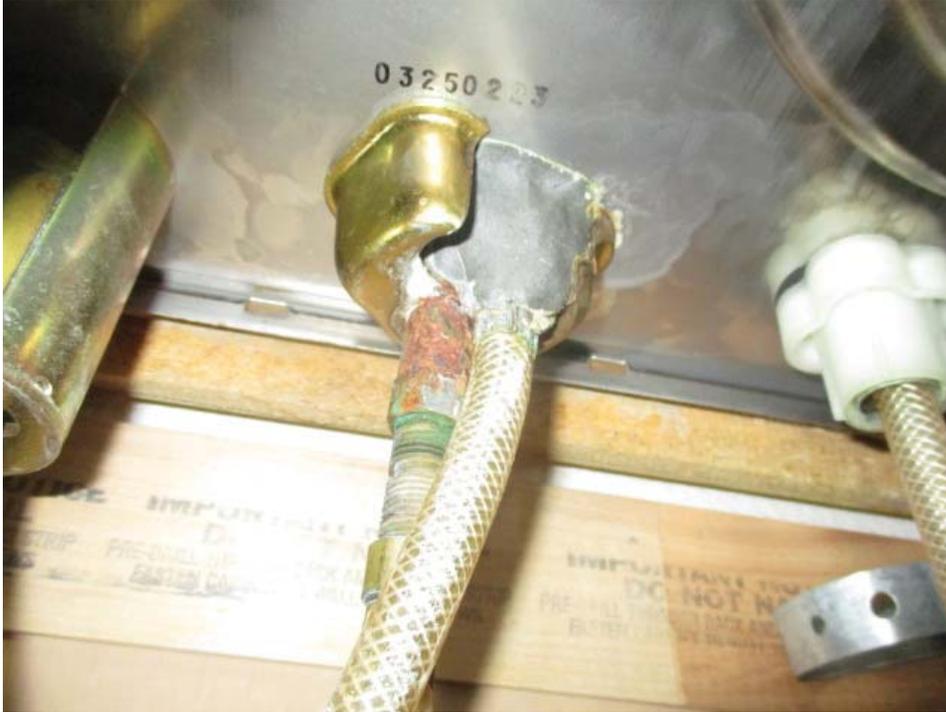
Rust and corrosion were found under the kitchen sink at the faucet connection, recommend ensuring the faucet is properly sealed to the sink.

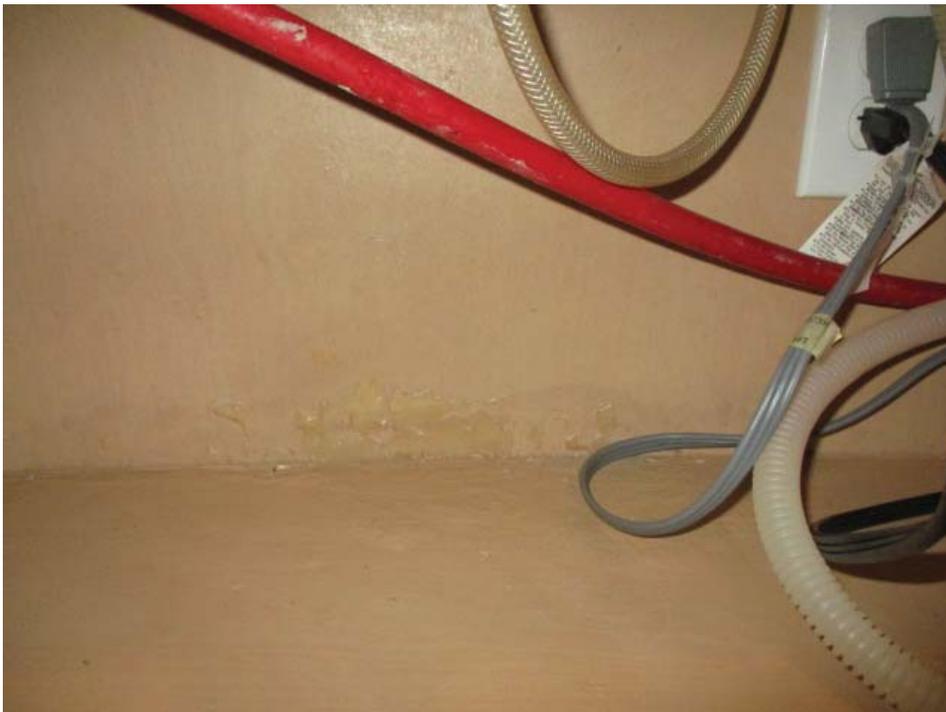
30

Moisture damage was noted under the kitchen sink. No current moisture issues were found.

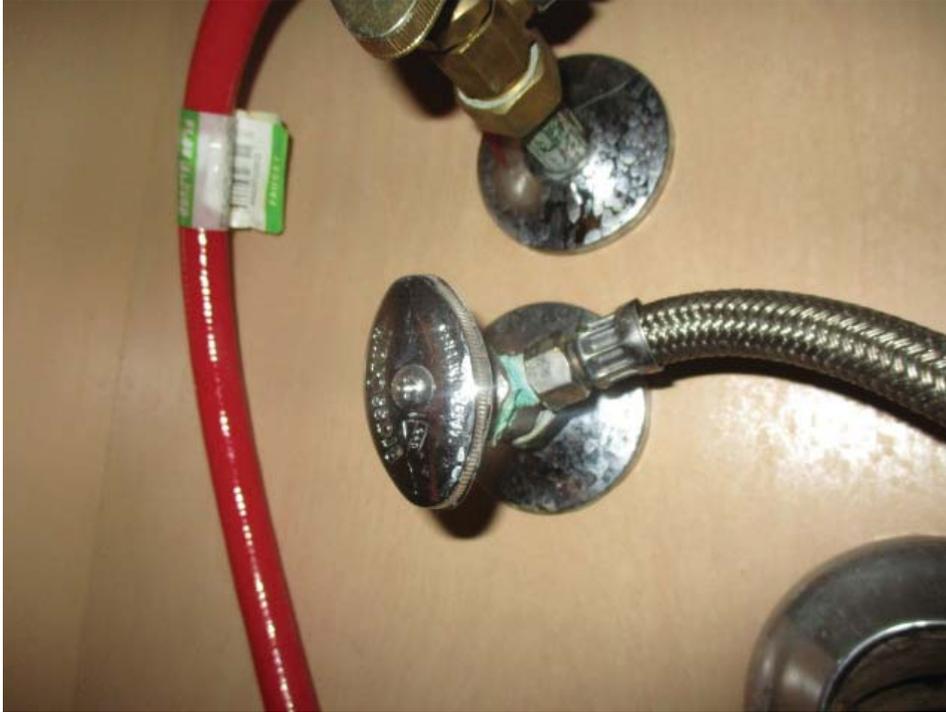
31

Water supply valves and supply lines at the kitchen and bathrooms including the toilets are aging and/or corroded, recommend replacing.

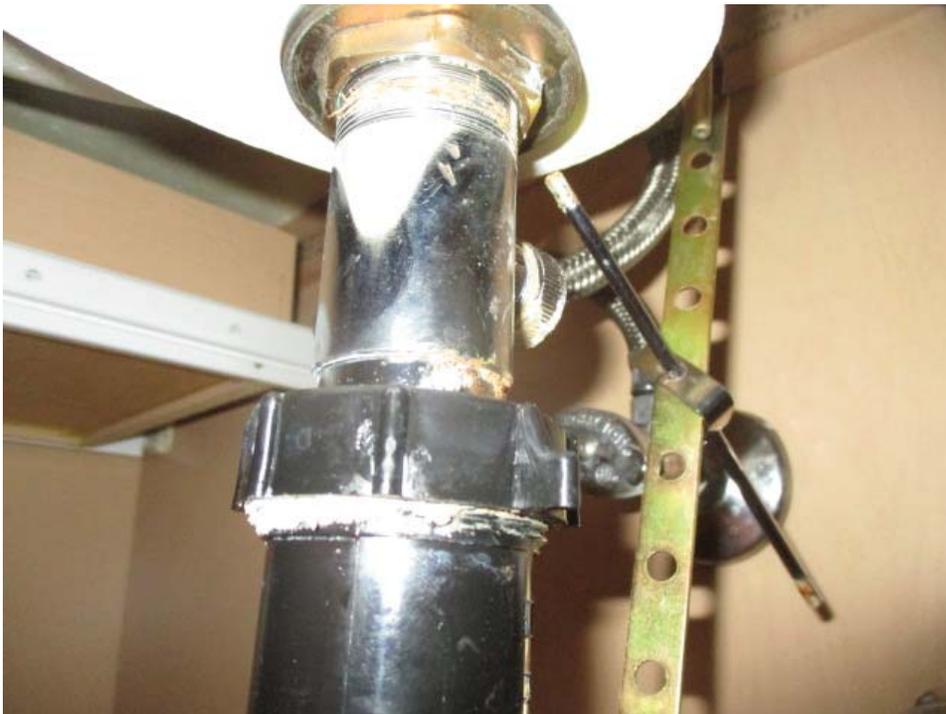
32

Drain pipe is corroded in master bath B. No current moisture issues were found.

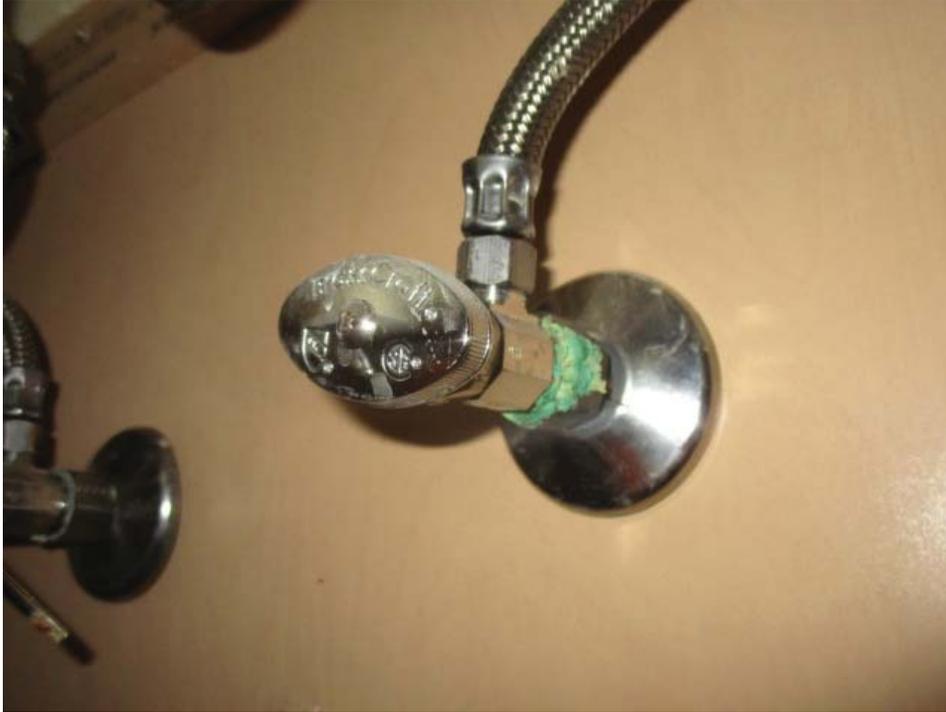
Water supply valves and supply lines at the kitchen and bathrooms including the toilets are aging and/or corroded, recommend replacing.
