Thank you for selecting CPI for your property inspection.

Inspector : **Ruth Lindley**

**Report ID#**

**HE0919RL**

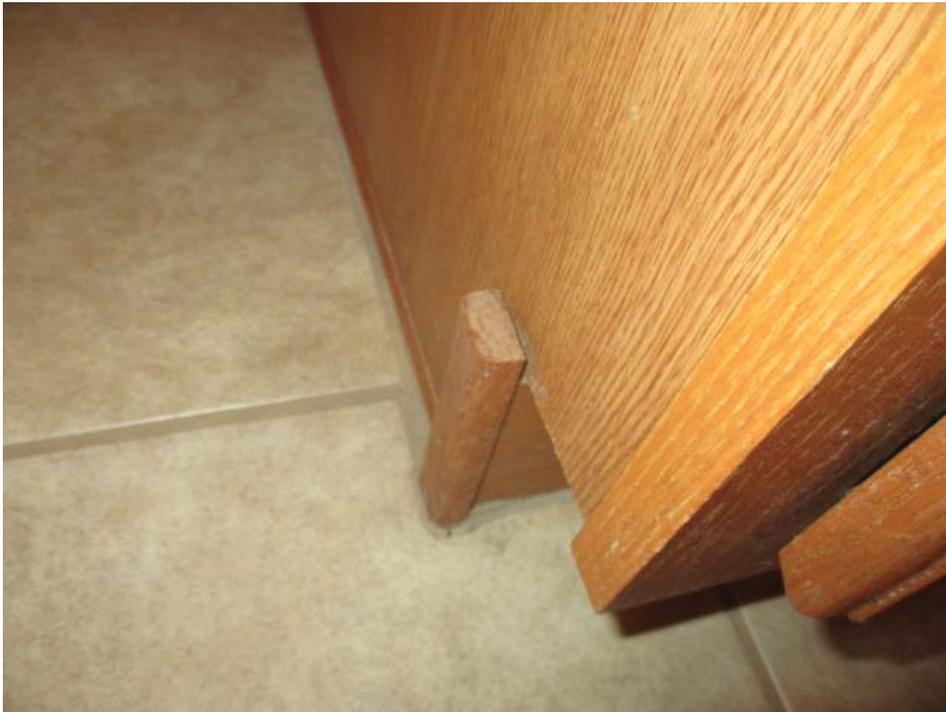
34

Trim for the bathroom cabinet is loose in master bath B, recommend securing.

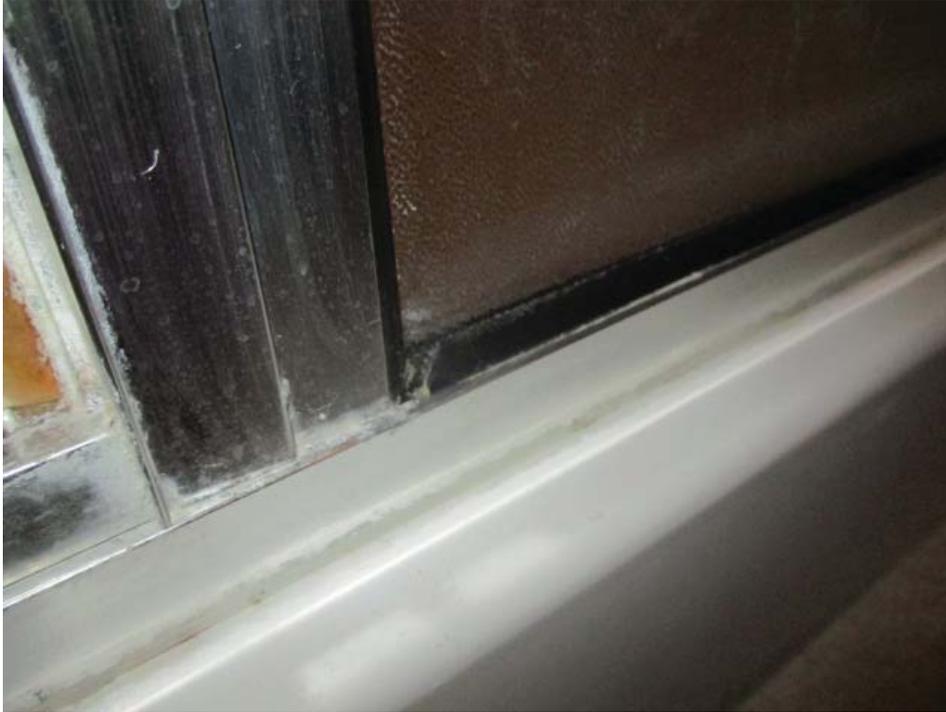
Deterioration was observed to the shower enclosure glass seals in master bath B. Recommend replacement / repairs to ensure water tightness of the enclosure.

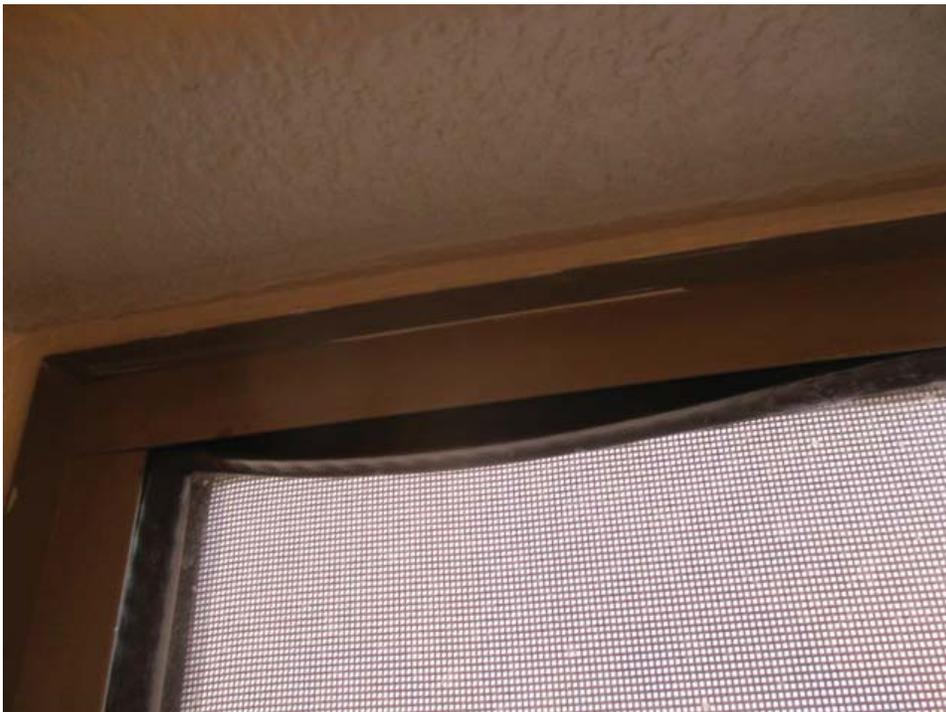
36

Window seals are damaged or displaced in various areas including the kitchen, bedroom #2 and both bathrooms.\*

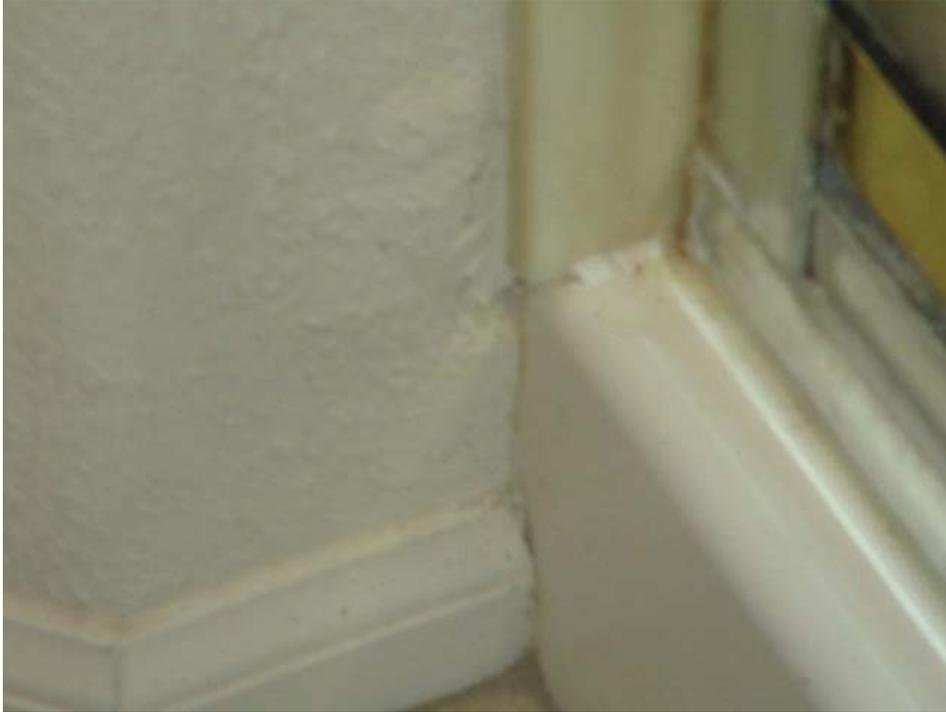
37

Moisture damage was observed to the wall and/or baseboard at the shower-wall area in bath , recommend replacing damaged materials as needed as well as resealing the enclosure.

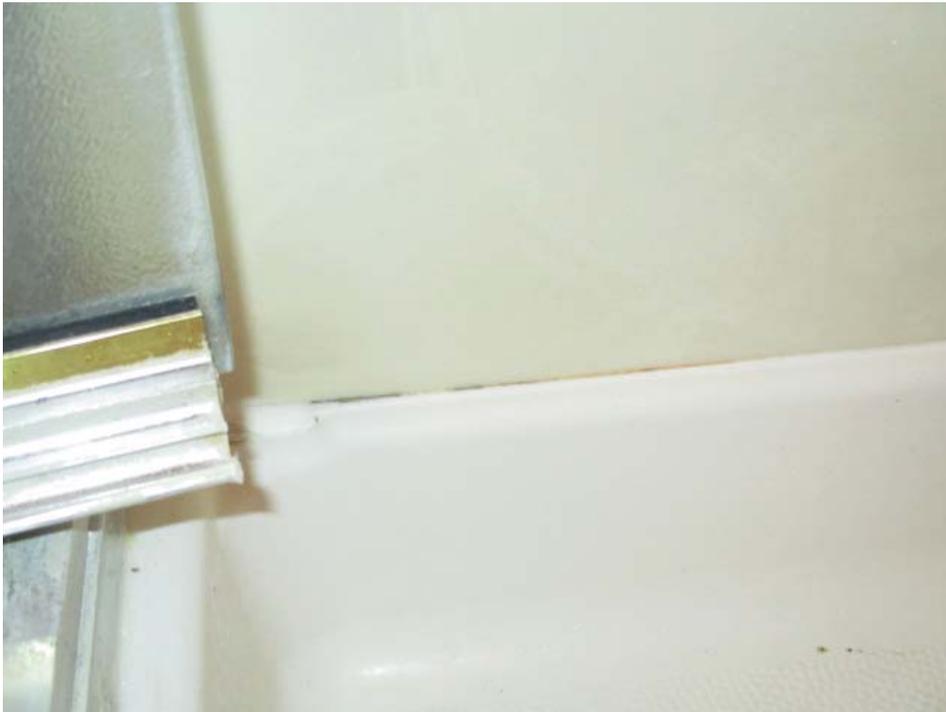
38

Minor separation and mildew stains were observed in the shower caulking in master bath B, recommend cleaning / replacing as needed.

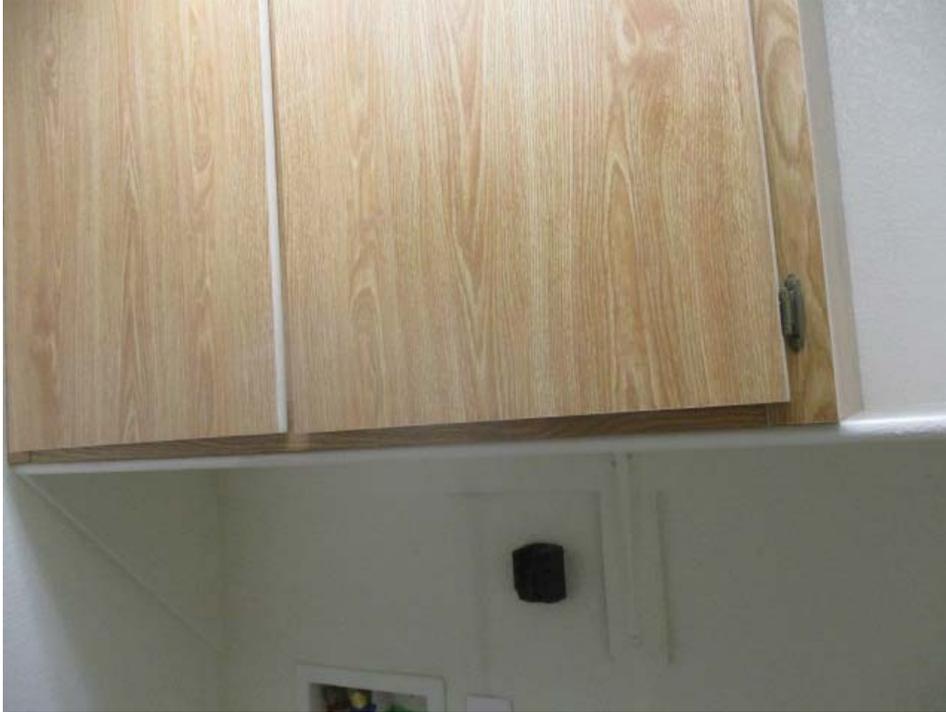
39

Cabinets in the laundry do not appear to be secured and may be too heavy for the shelf, recommend removing.

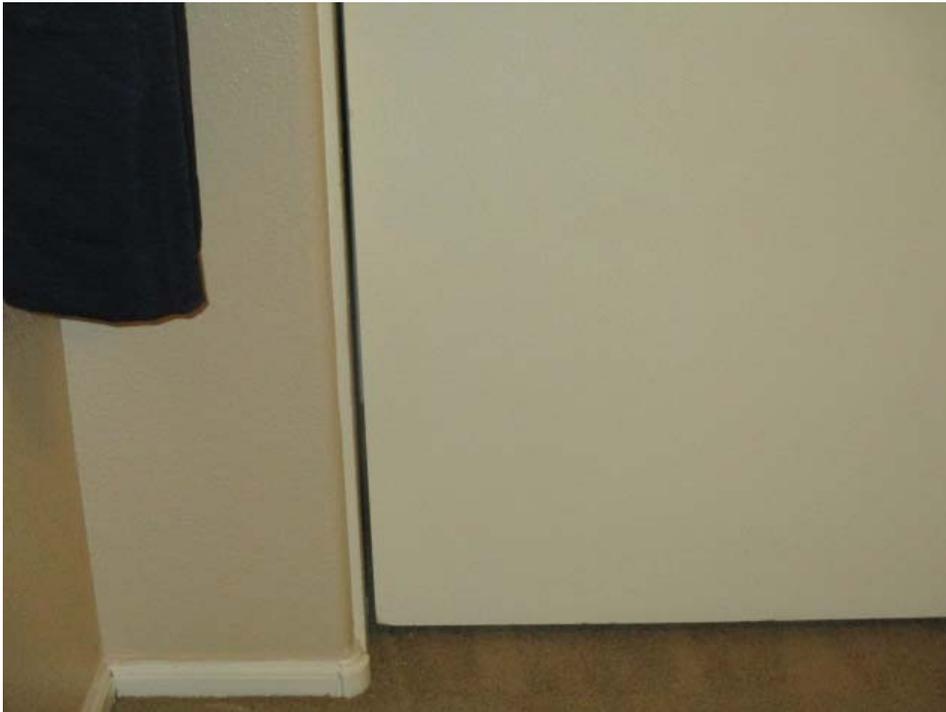
40

Closet doors need adjustment in bedroom #2.

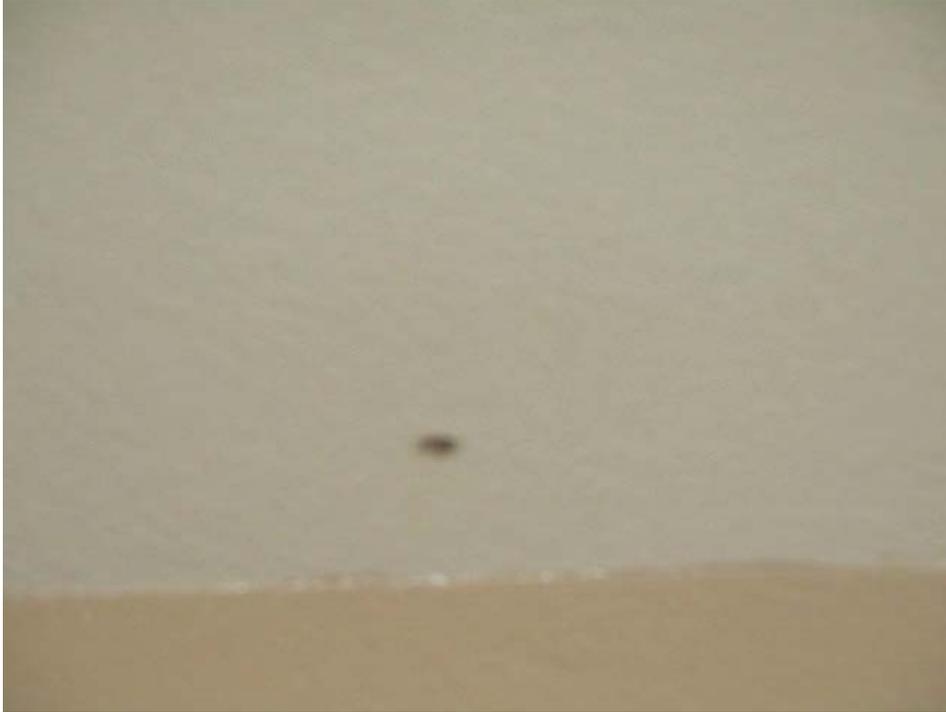
41

Common cracks and nail pops were found at the ceilings and walls in a few areas.

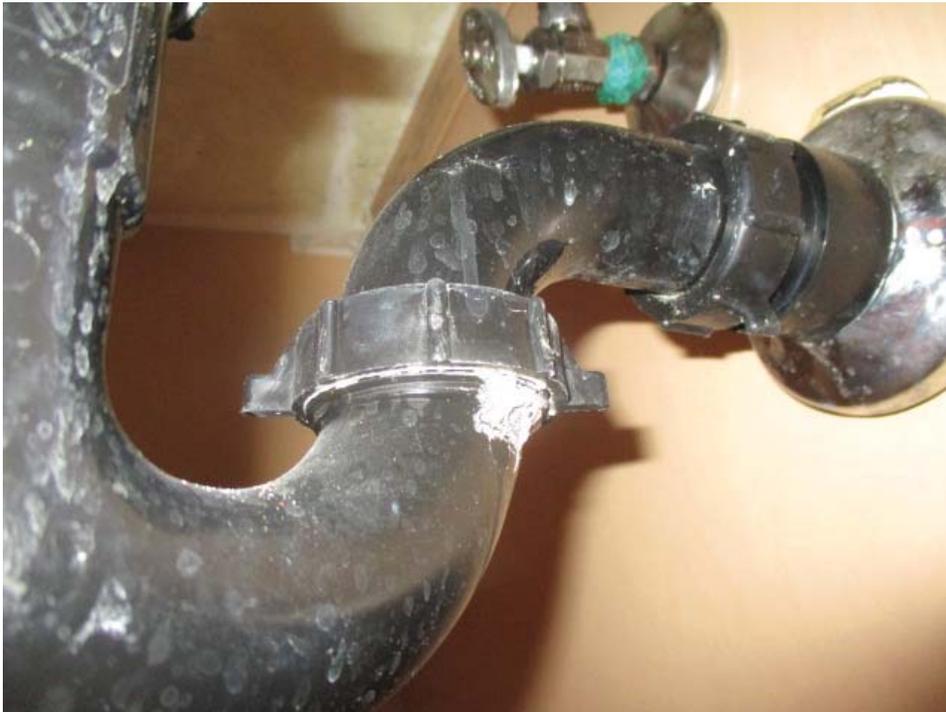
42

Drain pipes are corroded in main bath A and master bath B. No current moisture issues were found.\*

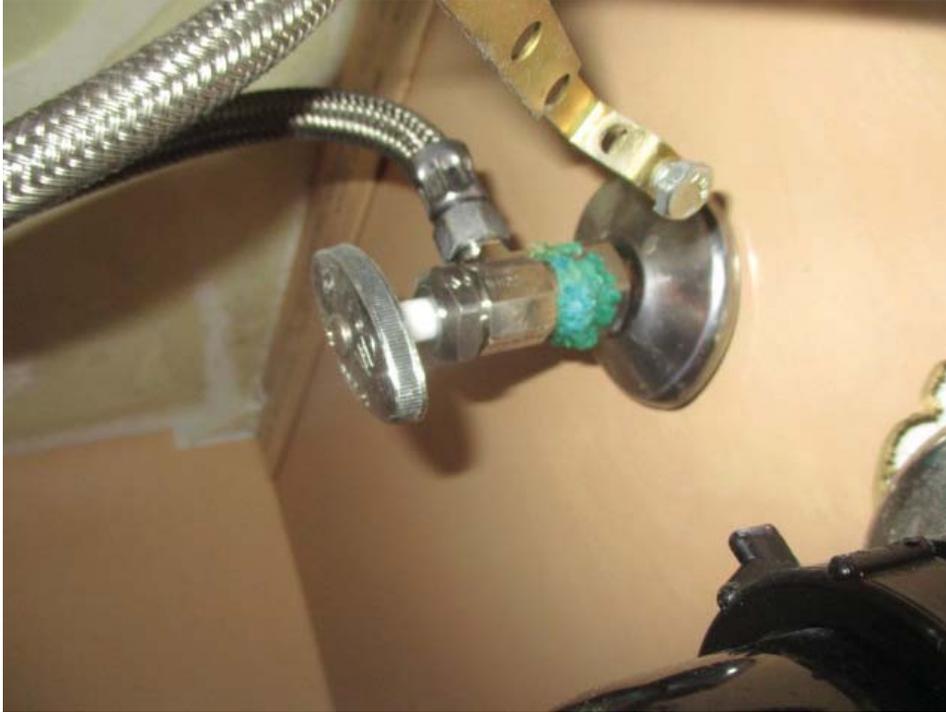
43

Water supply valves and supply lines at the bathrooms including the toilets are aging and/or corroded, recommend replacing.

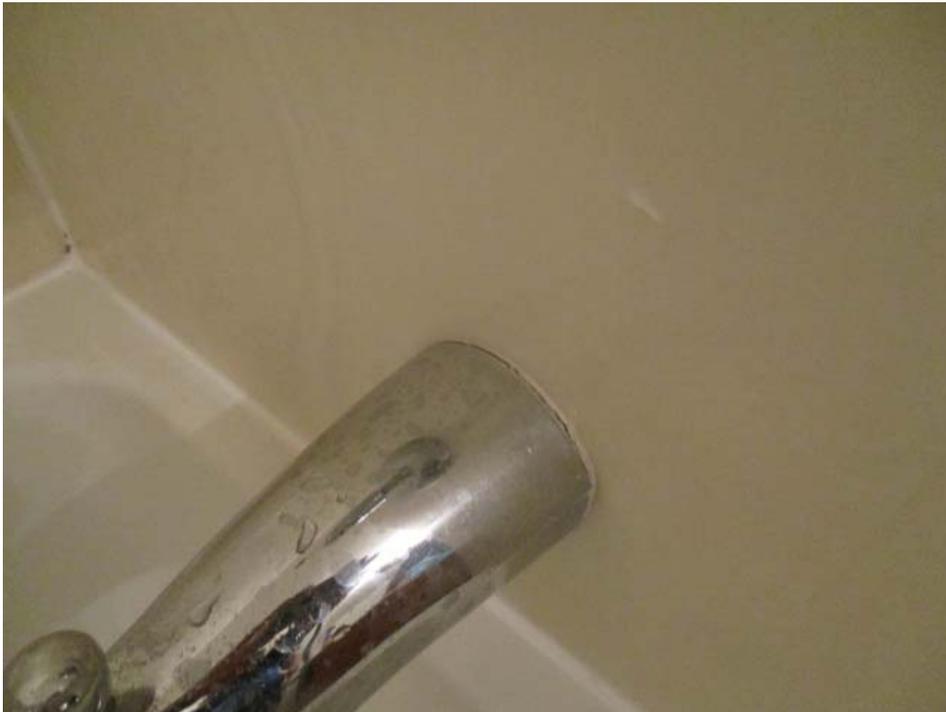
44

Recommend sealing the tub spout to the wall in main bath A.

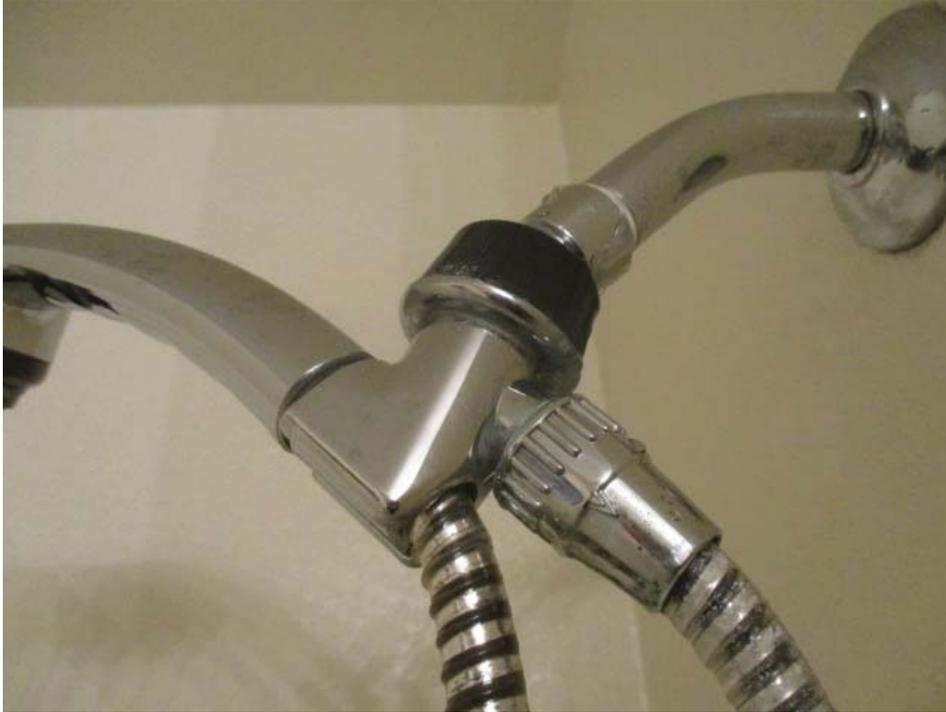
45

Shower head leaks when operated in main bath A.

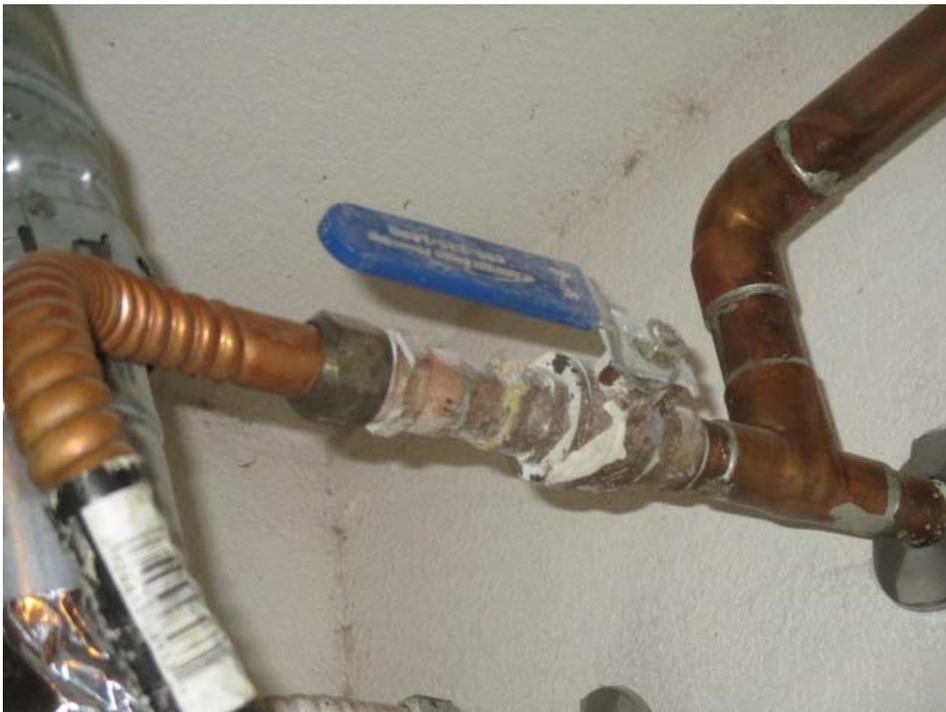
46

Water shut off valve is corroded at the water heater, recommend replacing.

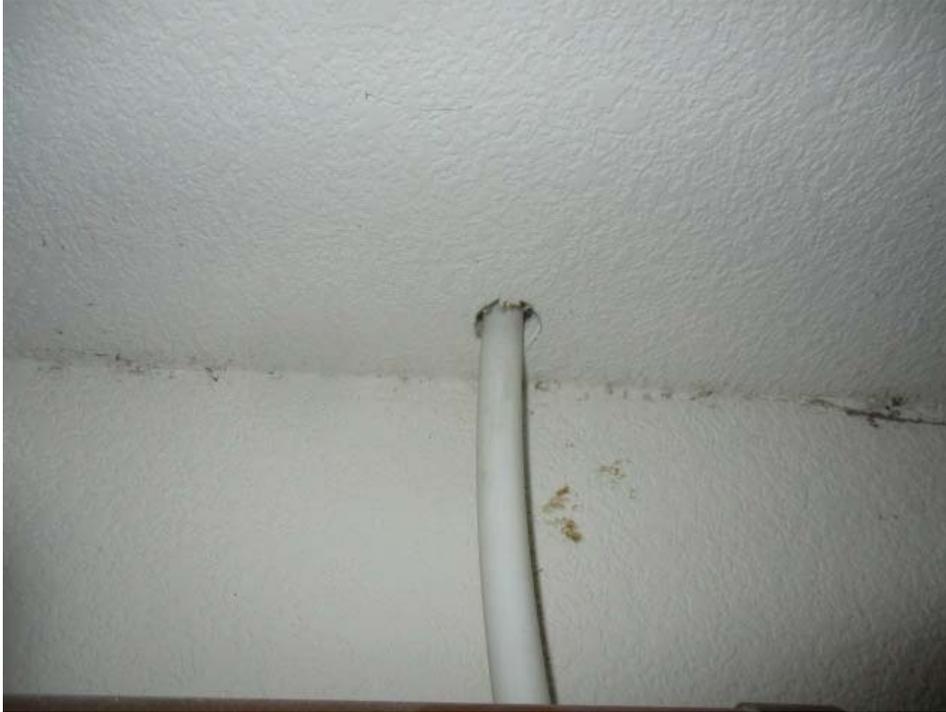
47

Drain line for the water softener passes through the garage firewall, recommend rerouting the drain line and repairs o the opening.

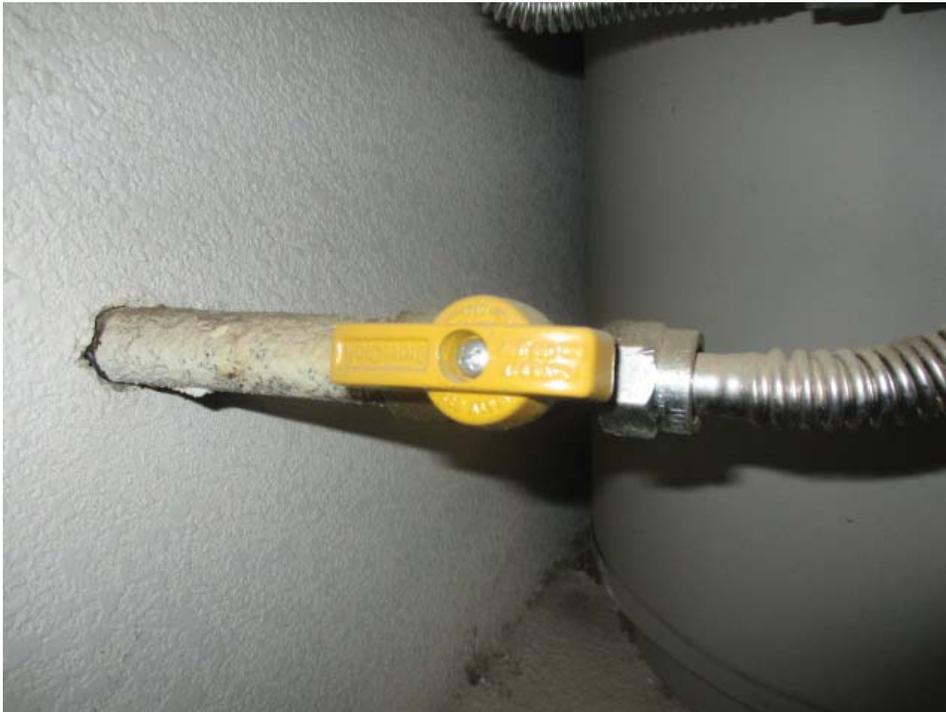
48

No visible sediment traps are installed in the fuel lines for the water heater and furnace, recommend adding for proper operation of the appliances.(2)

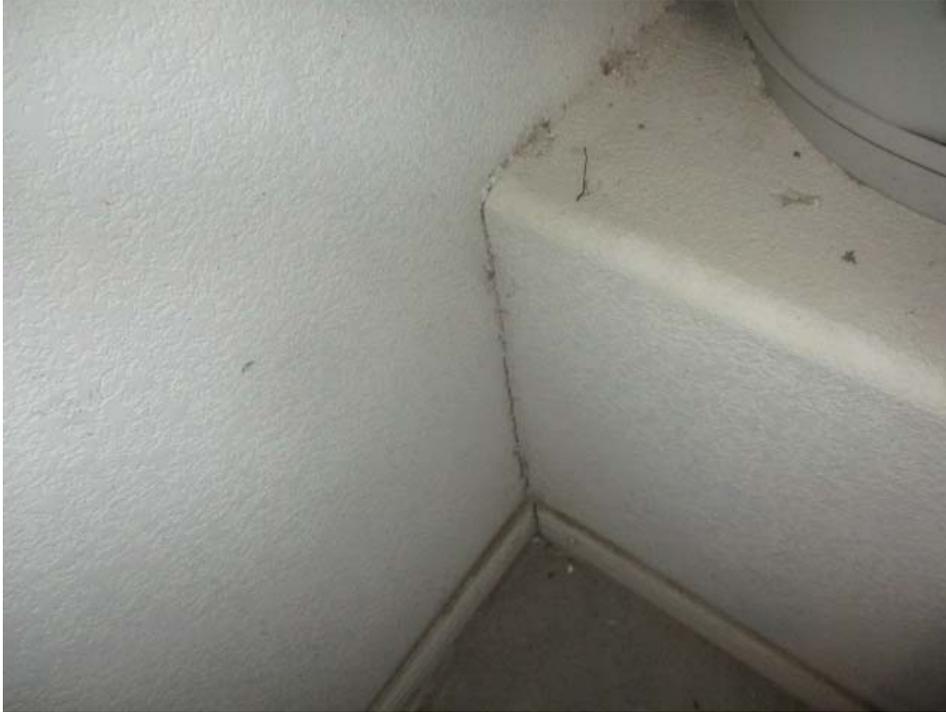
49

Common cracks were noted at the water heater platform.

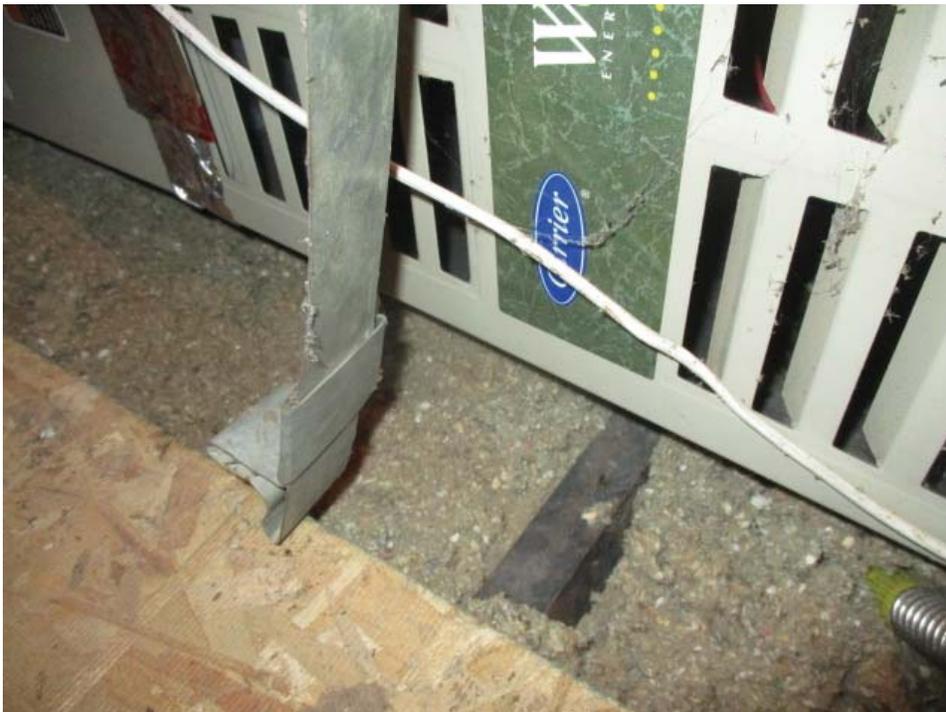
50

Support strap for the attic air handler is loose or disconnected, recommend repairs for proper support of the unit.

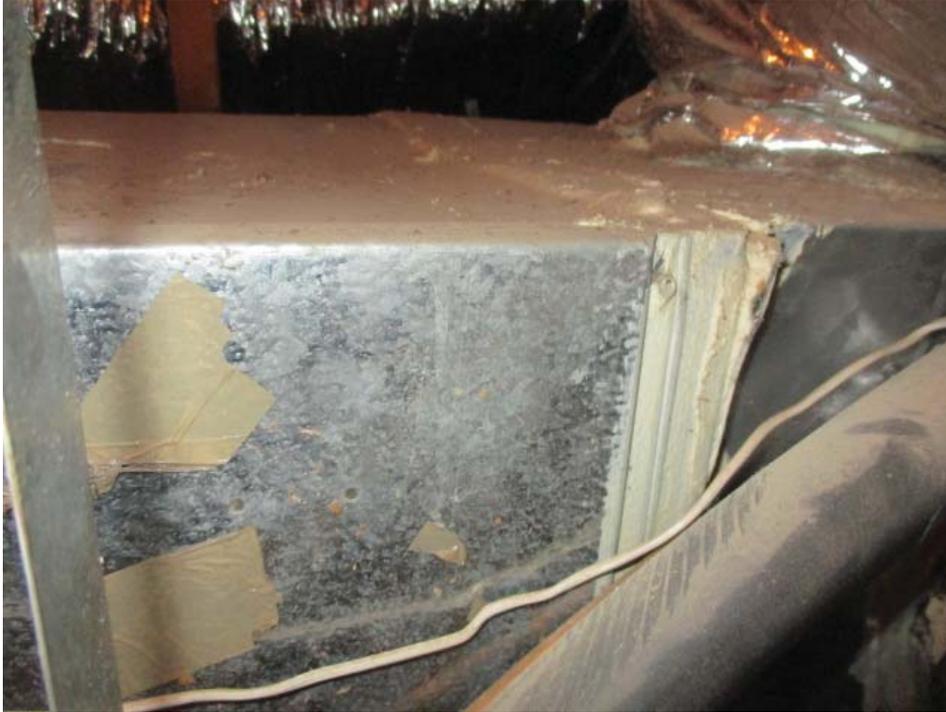
51

The attic air handler coils were not accessible, as the unit was sealed.

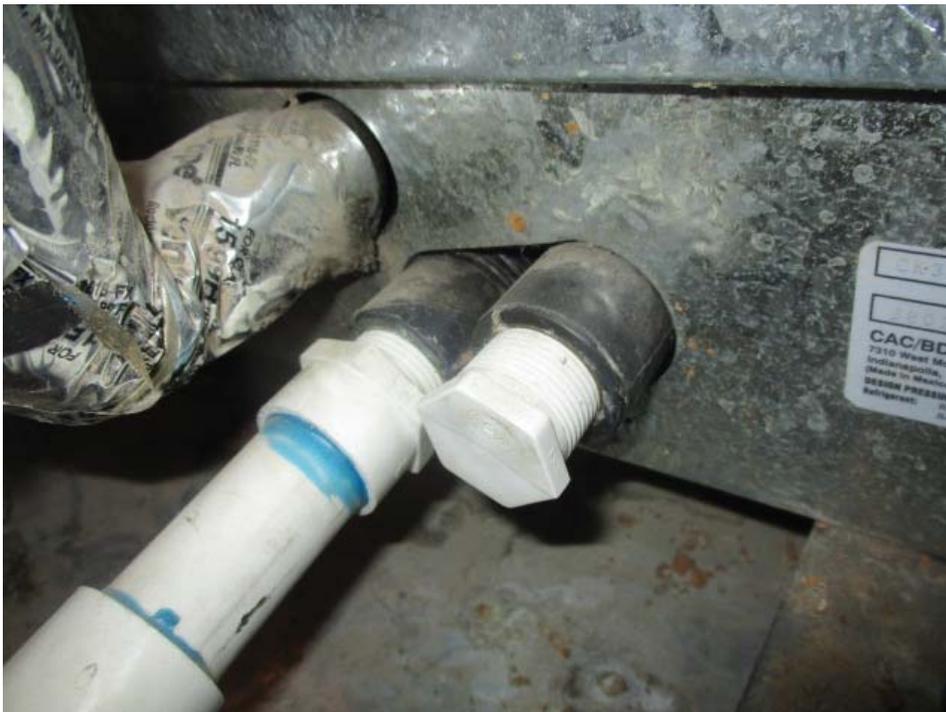
52

Recommend replacing the plug in the secondary drain port in the attic air handler coil cabinet with proper type fitting to allow drainage out of the unit and into the catch pan if the primary drain line becomes restricted.

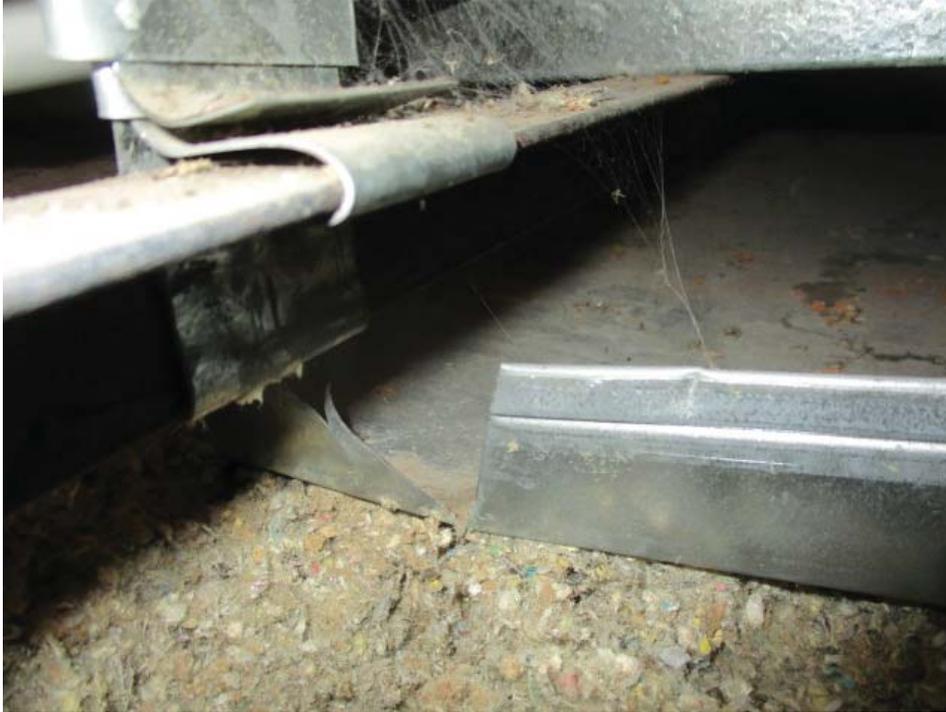
53

Secondary catch pan for the attic air handler has been cut below the drain line, recommend replacing the pan to prevent moisture damage in the event the secondary pan becomes active.

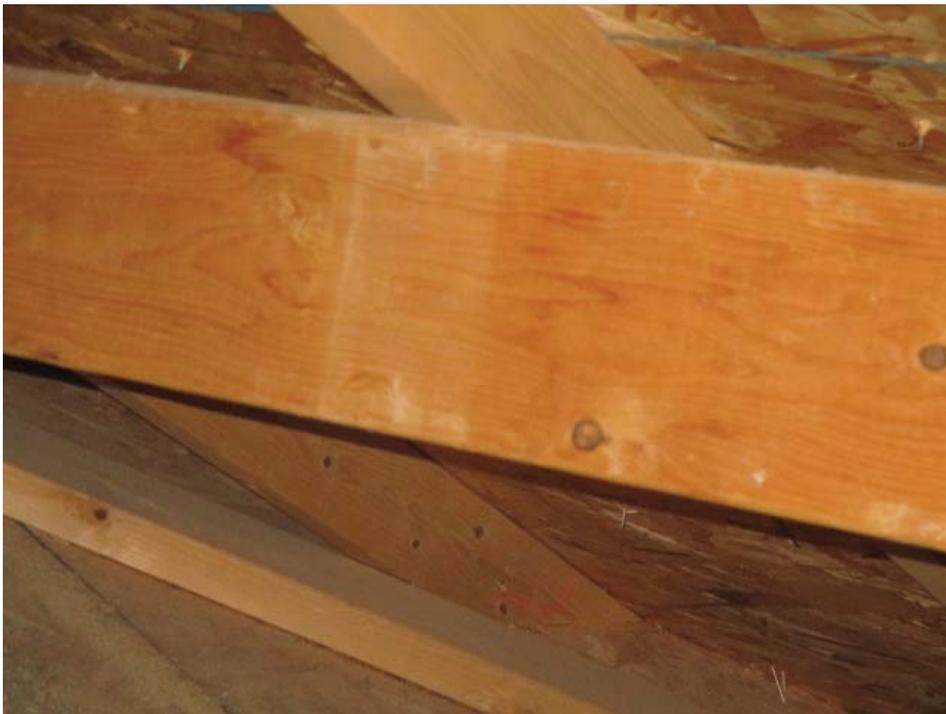
54

Moisture stains were found in the attic at the rafter for the north hip, recommend further evaluation of the roof and repairs as needed.(2)
